**TOHOKU GAKUIN UNIVERSITY
GRADUATE SCHOOL OF HUMAN INFORMATICS**

**LARGE SCALE LANDSLIDE RISK EVALUATION BY
AERIAL PHOTOGRAPH INTERPRETATION AND
INTEGRATED AHP APPROACH FOR HUMID TROPICAL REGION
BASED ON JAPAN AND VIET NAM FIELD SURVEYS**

DISSERTATION

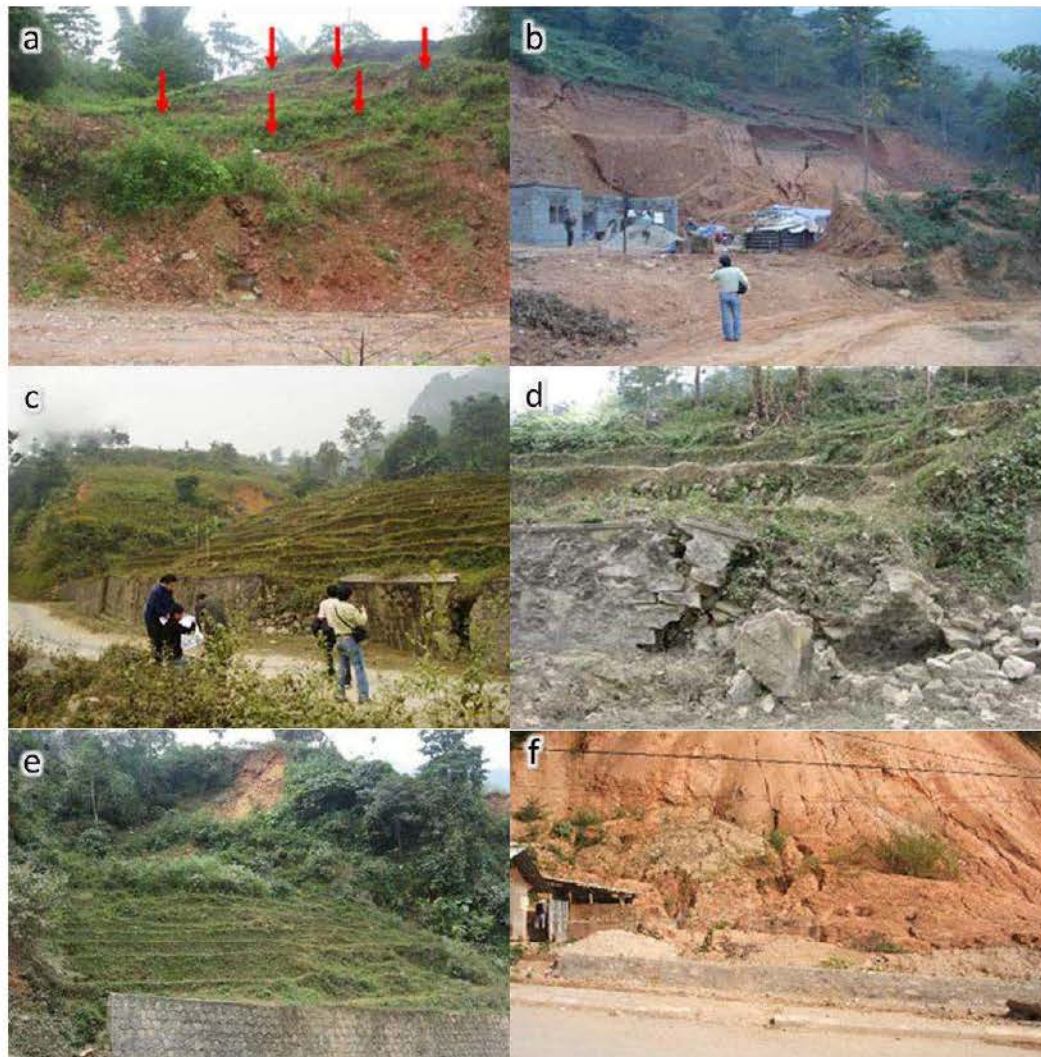
*Figure 2.1 Some images of landslide at the Coc Pai town (Tran, 2009):
a: rotational slide next to the road; b, slope failure by slope cutting (two houses were demolished); c, d, e: landslide damage to retaining wall; and f: debris flow caused by weak and weathered materials*

Coc Pai town is located in Xin Man district, Ha Giang provinces, in northern Vietnam. Its geology, which comprises schist and quartz schist, sericite schist and graphite gneiss of Ha Giang formation, exhibits a layered structure. The area is affected by strong weathering processes with depth of the weathering crust layer changing from 15 m to 35 m. A high weathering crust is about 10–25 m (Tran, 2009). A field survey conducted in 2009 revealed 46 landslide locations in this area. Most landslides occur at the high weathering crust and are classified as rotational slides. Figure 2.1 shows some images of landslide in this area. The most dangerous landslide (500 m long, 300 m wide) is in a downtown area, which has high population density. The town hall, monument, and numerous constructions are in the middle of this landslide body (Figure 2.2). Monitoring data showed that it moved 1.0 m during 2005–2010 (Tran, 2009).

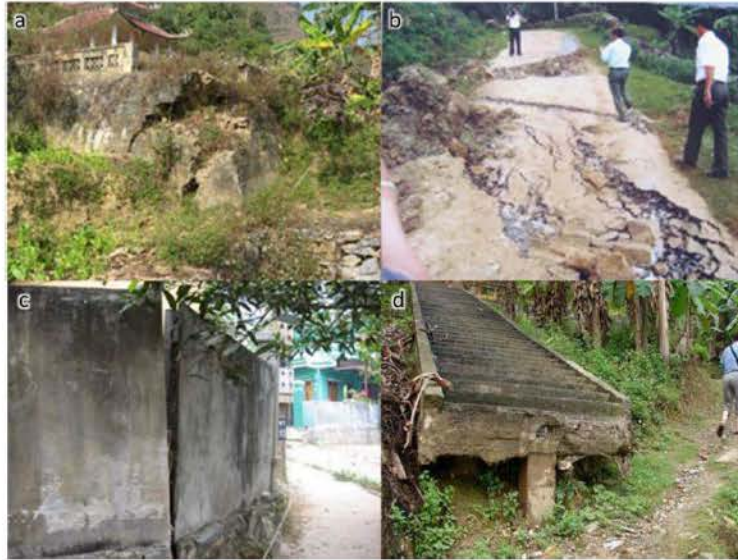
*Figure 2.2 Landslide damage in Coc Pai downtown (Tran, 2009):
 a: landslide-damaged monument; b: boundary of landslide cuts throughout the road; c: house
 fence tilting because of landslide; and d: landslide movement of steps*

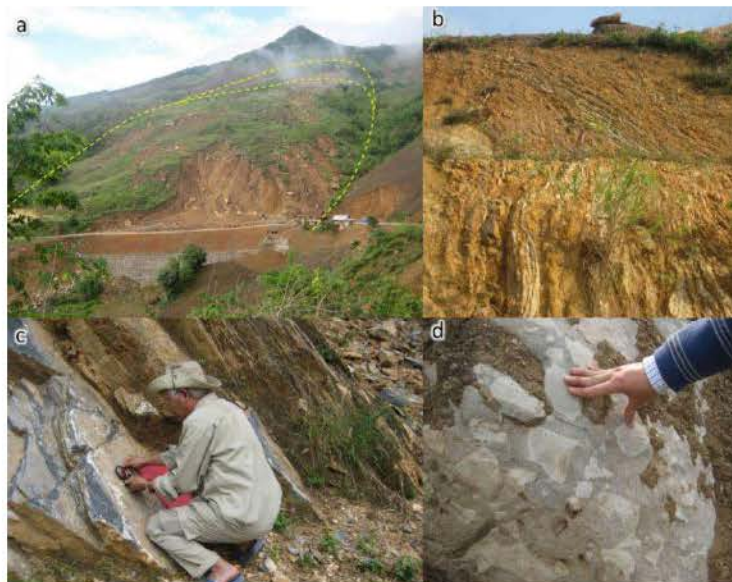
*Figure 2.3 Landslide at Km 447+900, National Road No. 37 (taken by Vinh, 2009):
 a: overview of landslide; b: sedimentary rock bedding was bent because of intruded basalt; c:
 bedding plane parallel to slope; d: conglomerate*

National Road No. 37 passes through five provinces, starting from Sao Do (Hai Duong province) to Co Noi T-junction (Son La province). Along this road, slope failures and landslides occur frequently. The largest is located on Km 447+500 with 650 m wide and 950 m long (Figure 2.3). It first occurred during the rainy season 9/2008 and formed 10 m high main scarp. Subsequently, some minor slide appeared. We observed five scarps in this landslide and the road was depressed 0.2–0.5 m and moved 0.3–0.5 m to a river, but it still moves now despite the establishment of countermeasures.

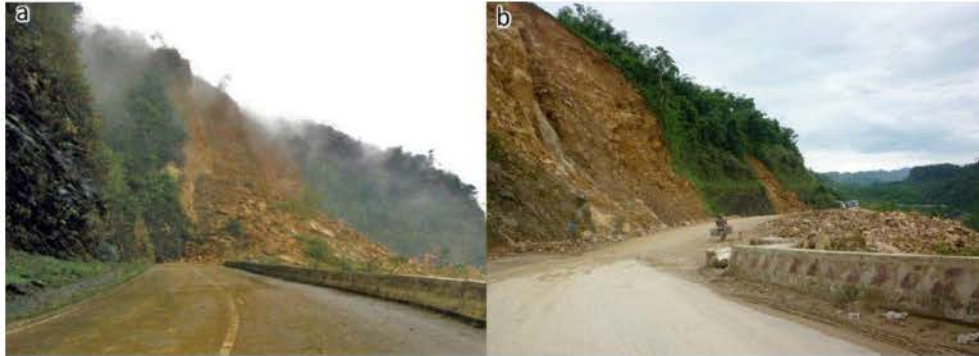
Figure 2.4 Landslide at Km 138+750 (a, Pham, 2014; b, photograph by Le): a: this picture was taken at the time the landslide occurred, 30,000 m³ debris fell after a period of heavy precipitation and caused traffic congestion in 7 days; and b: was taken two weeks after landslide occurrence

On National Road No. 6, landslides occur frequently every year during the rainy season. Most have occurred at section between Hoa Binh and Son La city, destroying houses and structures, blocking roads, and causing many deaths. During an intense storm on 10/2007, 400–500 mm of rain fell in 20 hr, inducing 20 landslides along the road, destroying many kilometers of roads, and killing two people, later blocking the road for 7 days. The government paid 200 billion VND for cleaning and countermeasures. However, landslides continued in 2012, when 30,000 m³ of mass collapsed on Km 138+750, producing traffic congestion for several days (Figure 2.4). Figure 2.5 depicts another example of a landslide along national Road No. 6.

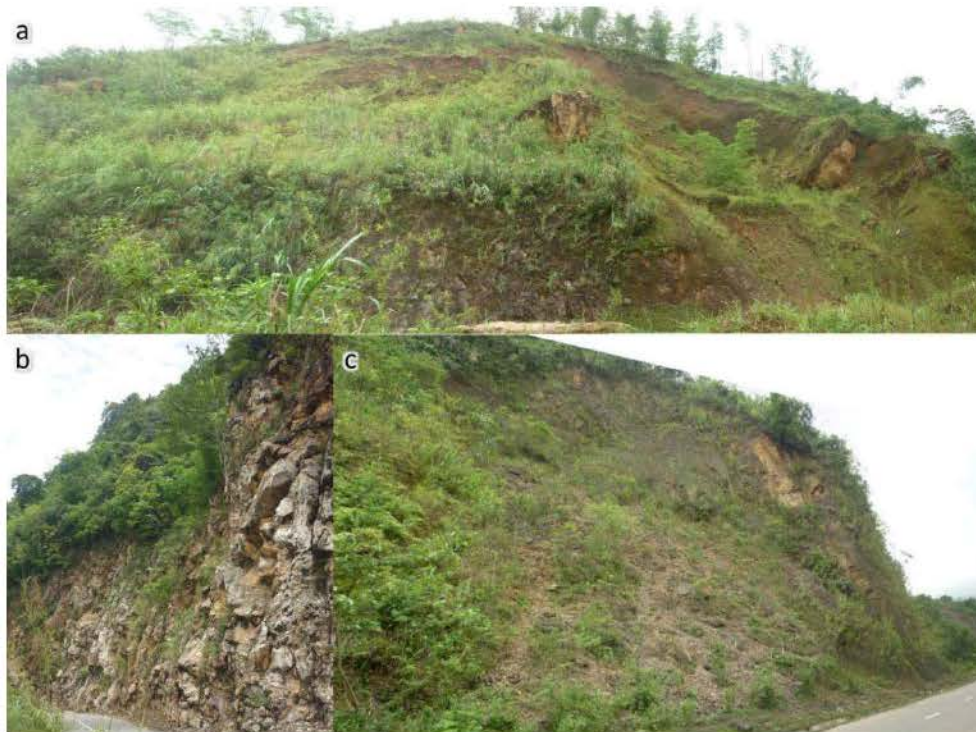
Figure 2.5 Some pictures of landslide along National Road No. 6 (photograph by Le): (a: landslide at Km 141+200; b: rockfall and topple at Km 128+700; c: rotational slide at Km 111+850).

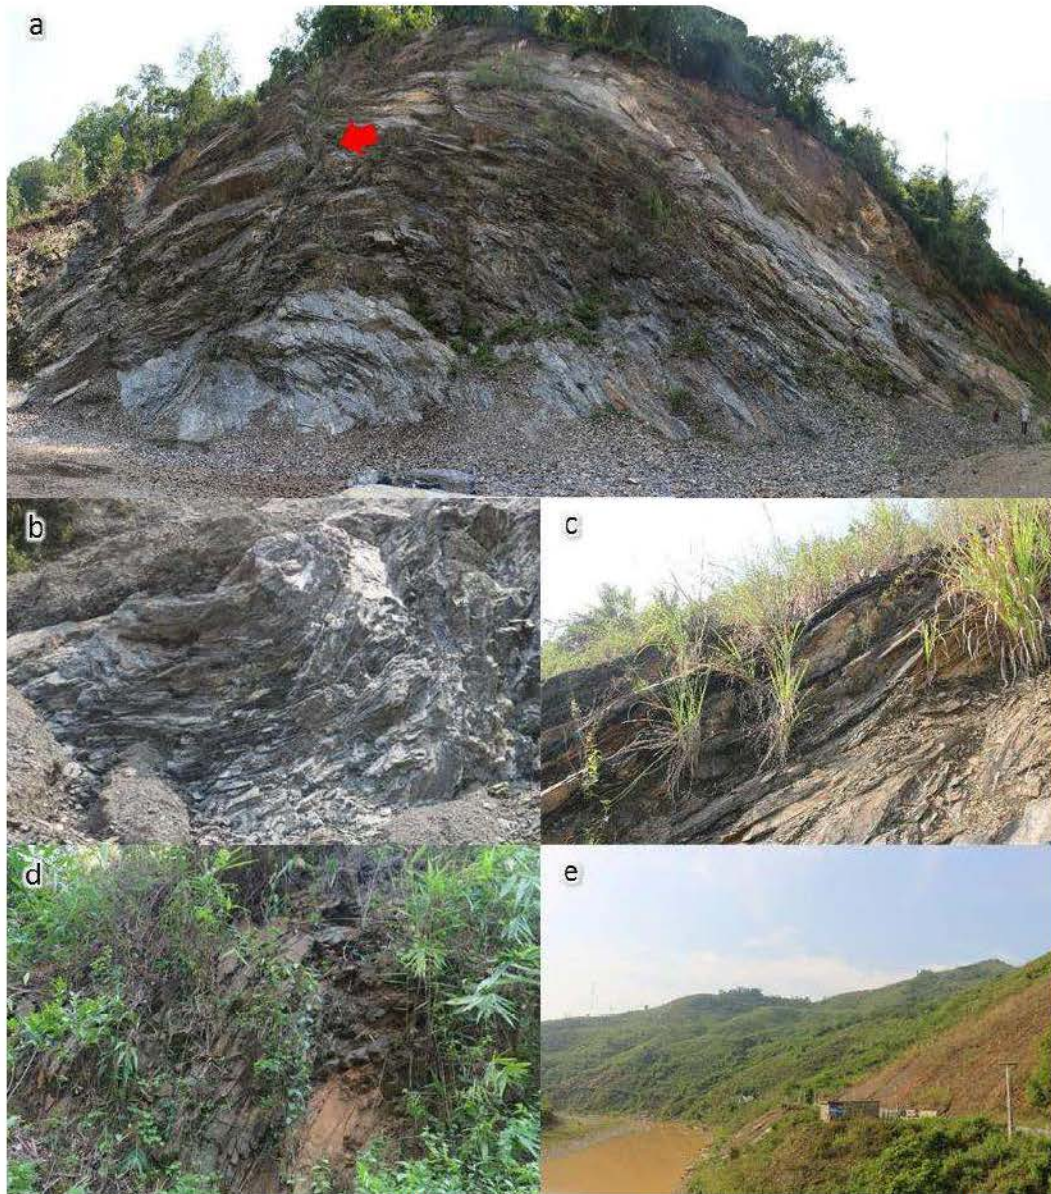
Figure 2.6 Typical example of landslide related to geology (Silurian) in National Road No. 7 (Le et al., 2015b):

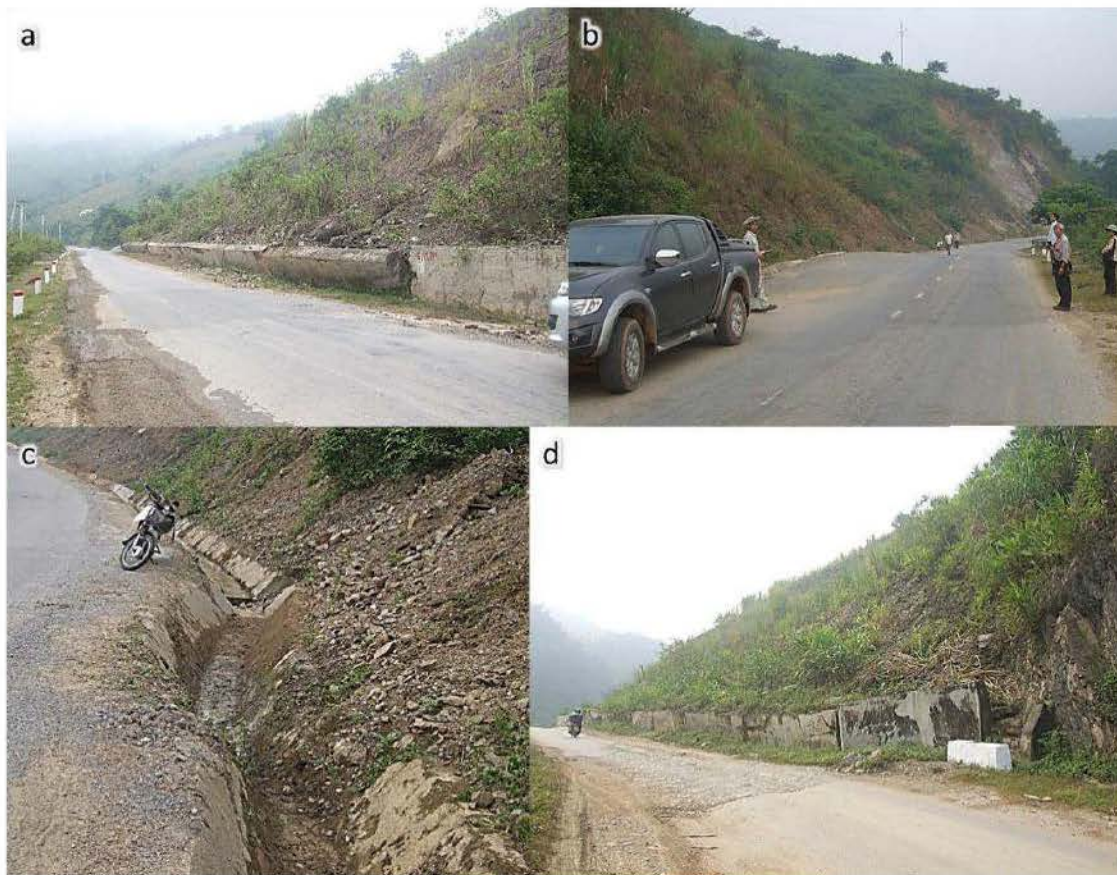
*Figure 2.7 Images of landslides along National Road No. 7 (photograph by Le):
a: retaining wall damaged by landslide; b: road was uplifted; c: ditch was bent; and d:
landslide damage to a road and retaining wall*

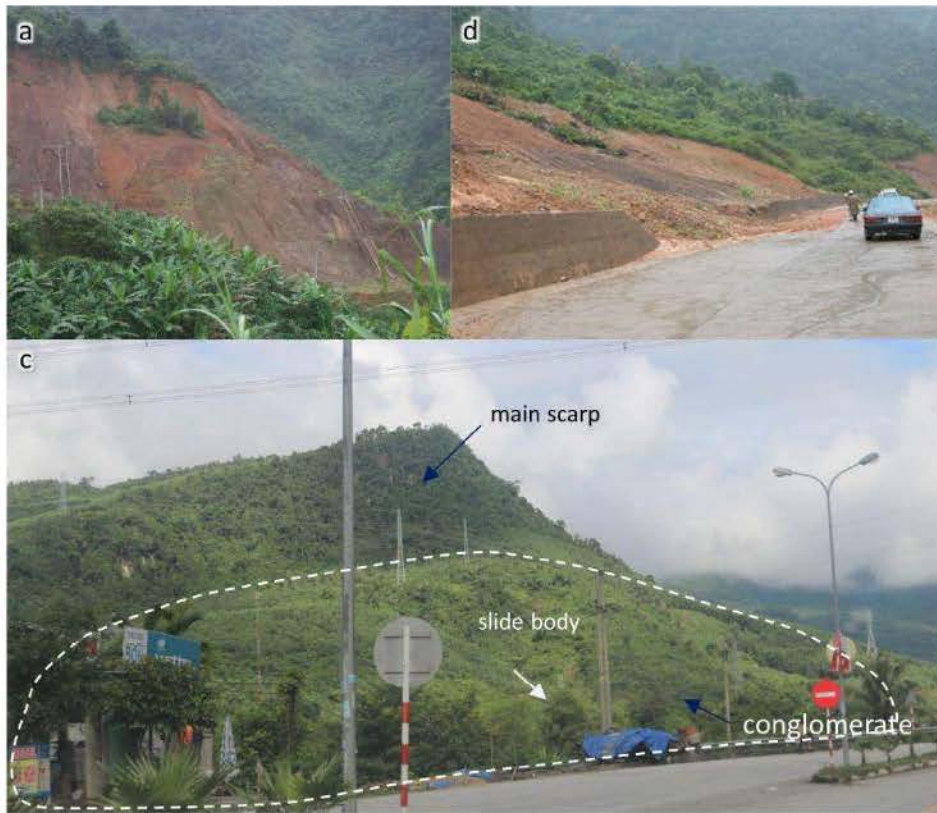
*Figure 2.8 Some typical landslide in Ho Chi Minh Road (1)(a and b taken by Ngo; c: photograph by Le):
a: rotational slide; b: debris flow damaged a middle segment of retaining wall; c: old landslide next to Thanh My Bridge, with an extremely clear scarp and body*

According to the Ho Chi Minh project management unit report (2010), 1600 landslides and slope failures have occurred, accounting for a total length of 146 km out of the current 2499-km-long Ho Chi Minh Road. These are concentrated mostly along the 1200 km from Quang Binh to Dak Lak province (central provinces of Vietnam), which can be divided into nine sections: Da Deo – Tay Gat section; U Bo Pass; Khu Dang Pass; Cong Troi Pass, Sa Mui Pass; Dak Rong – Ta Rut section; Hai Ham Pass; Song Bung Pass; and the Kham Duc – Lo Xo section. Many landslides result from the reactivity of aged landslides after slopes were cut for road construction. Most occur during the rainy season. Figure 2.8 and Figure 2.9 displays typical landslides in this area.

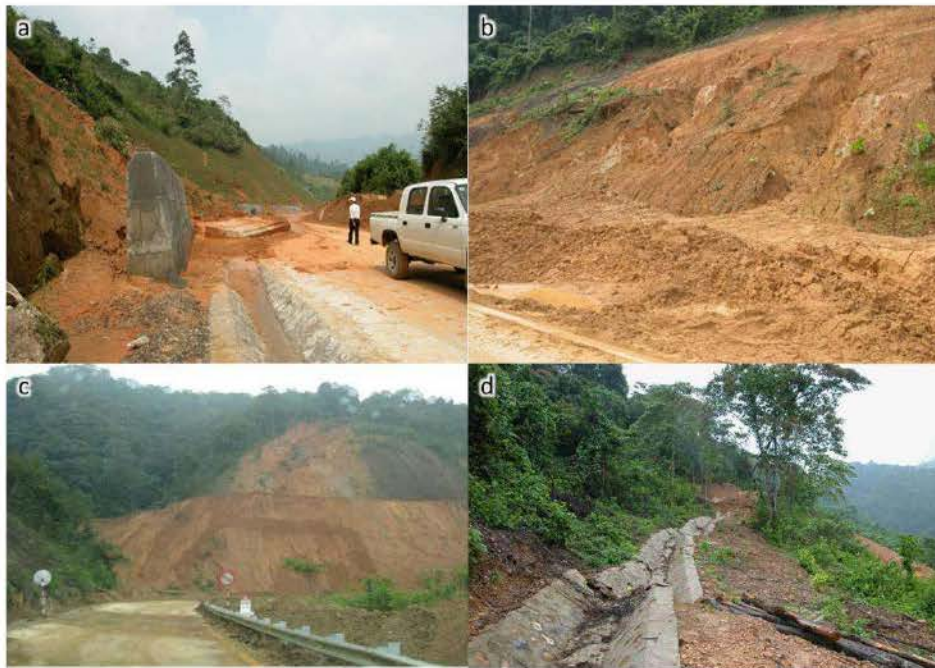
*Figure 2.9 Typical landslides in Ho Chi Minh route (2) (Doan, 2008):
a, b: debris slide at Km 339; c: rotational slide at Da Deo Pass; and d: rotational at Km516+713 damage ditch at upper slope. These landslides reactivated after a period of heavy precipitation*

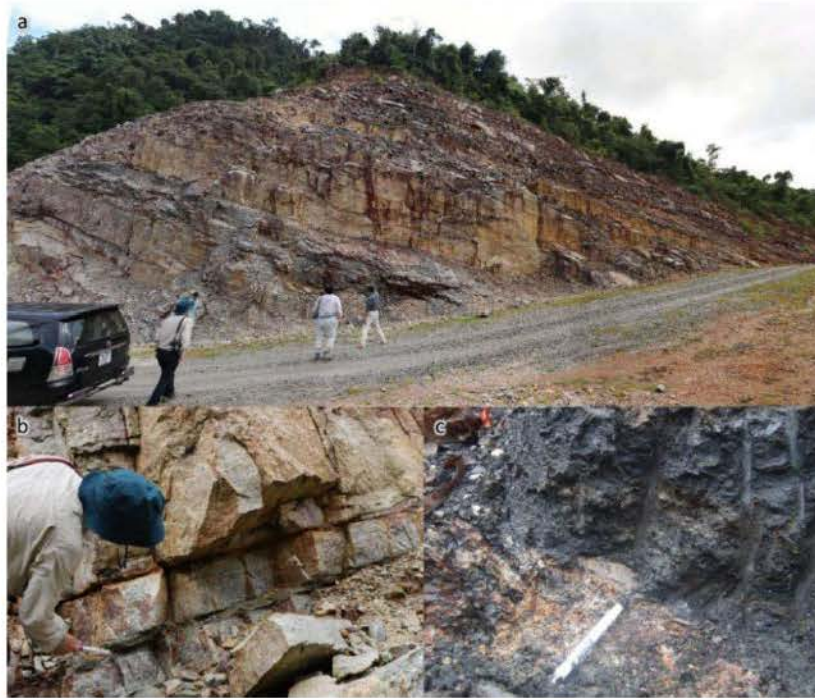
Figure 2.10 Typical geology structure of Song Bung Pass (Le et al., 2015a and 2015d): a: well bedded layer structures; b: some weak layer between sedimentary rocks; and c: lenses of coal layer, it is also a slip surface.

These landslides can be classified into seven categories: rock fall, rotational slide, translational slide, debris slide, debris flows, earth flows, and wedge type. Field surveys show that these landslides are related closely to geology and weathering. For example, landslides in Song Bung Pass are formed in well bedded sedimentary rocks such as cuesta landforms. Lenses of a weak layer (coal layer and mudstone) are observed in this area (Le, 2015a). Most landslides occur along a bedding plane and weak layer as translation slides Figure 2.10.

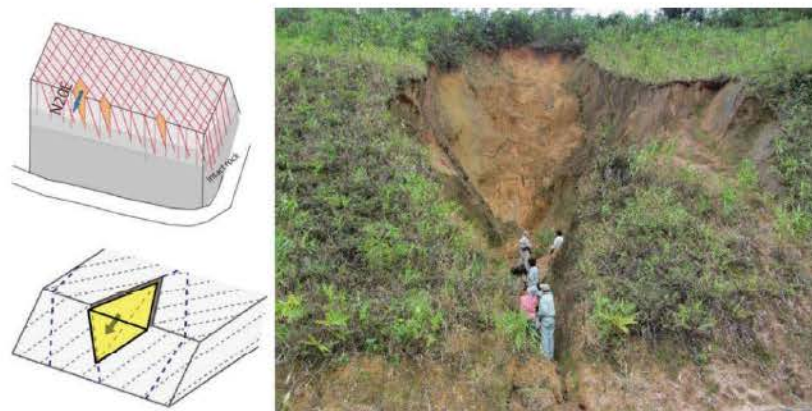
Figure 2.11 Wedge type in Ho Chi Minh route ($N16^{\circ}04'50.4''$, $E107^{\circ}29'17.2''$) (photograph by Ngo)

Another example of wedge type occurs in metamorphic rocks (Hai Ham Pass area). Cracks and fractures are well developed with many dips and strikes in this rock. These allow water to penetrate, enhance weathering, and weaken a potential sliding layer. Wedge type failures occur often along fracture planes.

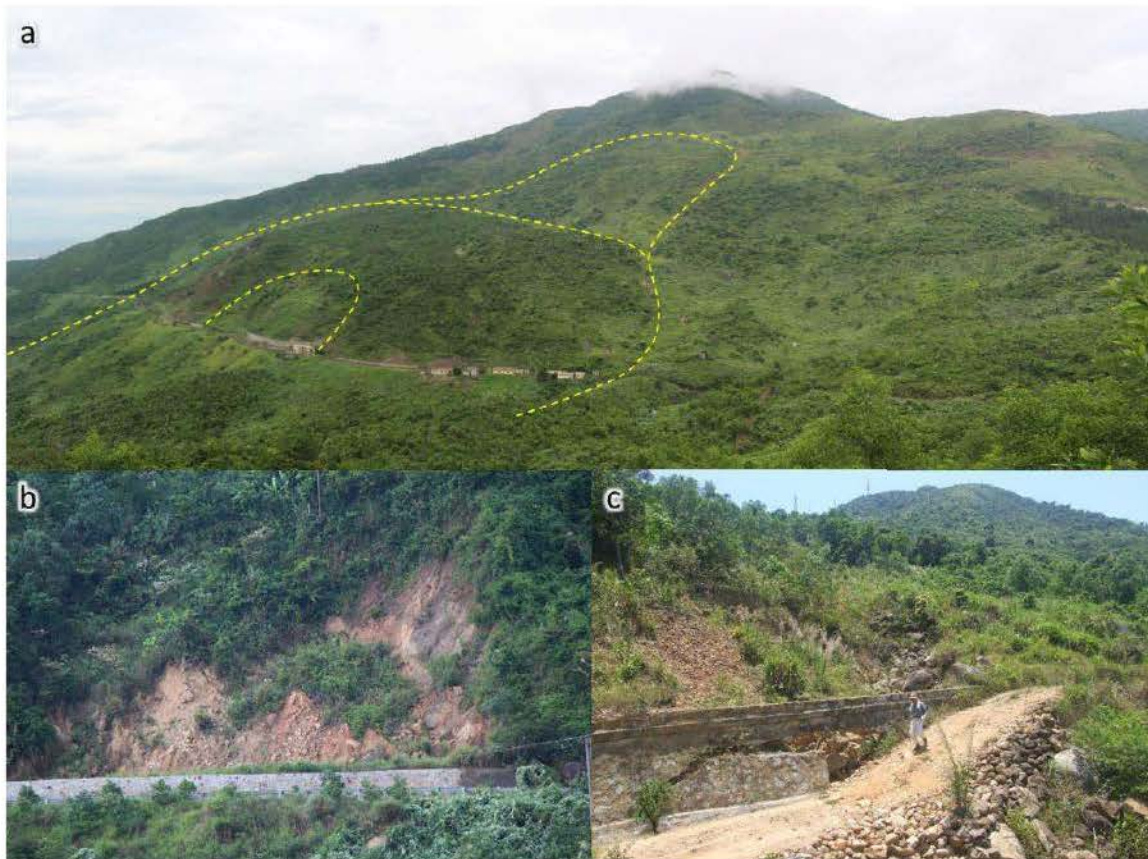
*Figure 2.12 Some landslide at Hai Van (a, photograph by Dinh; b, Tien et al., 2015; c, photograph by Le):
a: overview landscape of old landslide at Hai Van railway station; b: rotational slide; c: landslide damaged retaining wall*

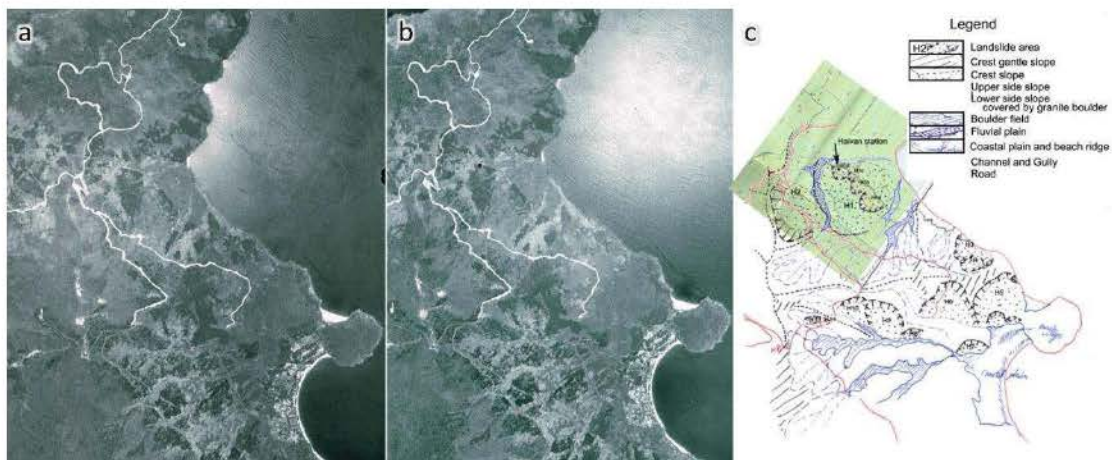
Figure 2.13 Aerial photograph and landslide inventory map at Ha Van Station area (established by Miyagi, 2014):

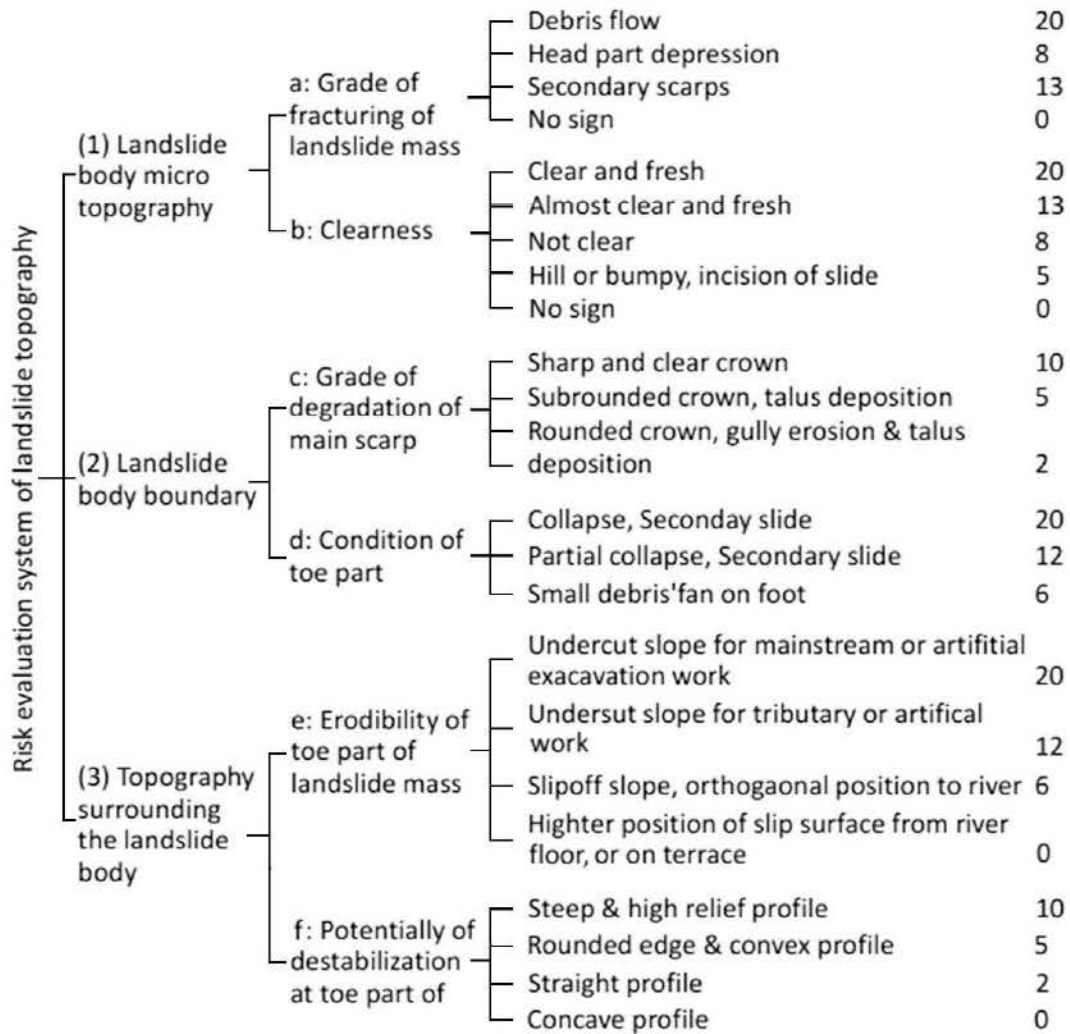
Figure 2.16 Risk evaluation criteria (Miyagi et al., 2004)

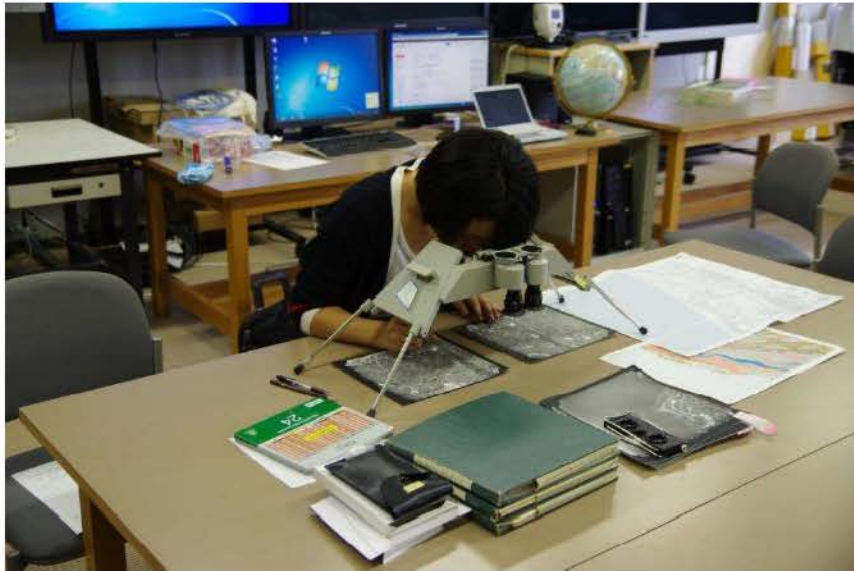
Figure 2.18 Picture of aerial photo interpretation (Miyagi, 2013) (performed using aerial photograph, stereoscope for aerial photography (mirror type), simple stereoscope, topography map, geological map, writing materials, etc.) The series of aerial photographs should be arranged as shown above, and be examined from directly above. The gap separating photographs differs depending on the person; fine tune the image by moving the photographs slightly until the image is clearly visible (Miyagi, 2013)

Analysis of landslides through aerial photograph interpretation (Figure 2.18) enables us to distinguish topographical areas created through landslides from those which did not result from landslides. Landslide terrain is clearly demarcated from general slopes through the landslide scarps (Varnes, 1978). The main part of a landslide is surrounded by slips and is recognized as consisting of moving objects such as the landslide body. Landslide topography is constituted by slip surface so-called surface of rupture and moving material called the landslide body. Various shapes and inclinations of slip precipices exist. Moreover, the moving parts

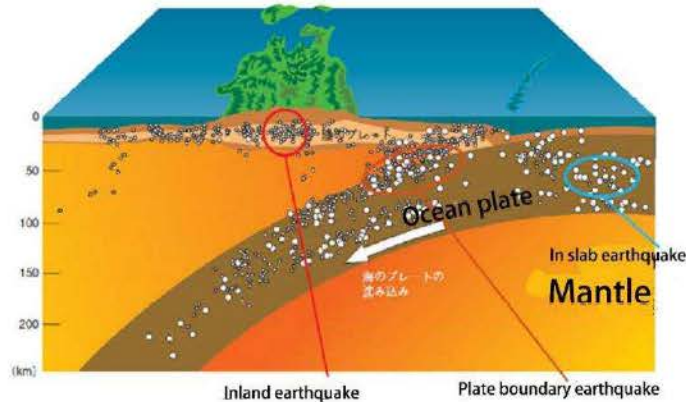
Figure 3.4 Cross section of the Tohoku district (modified from data of the headquarters of Research Promotion of Earthquake and Volcanic Disasters in Japan)

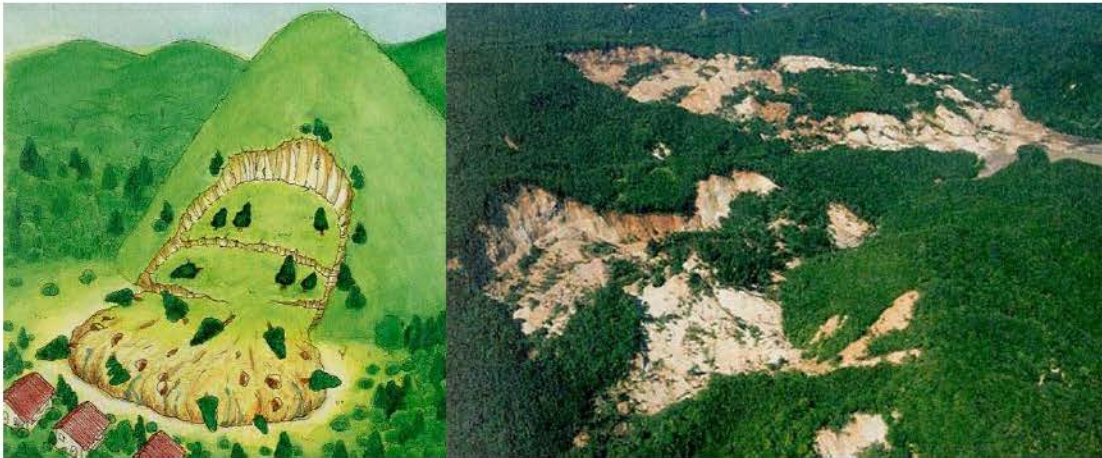
Figure 3.11 Shizumikurasawa deep-seated landslide in the upper reaches of Nihasamagawa (Forestry Agency Japan, 2015)

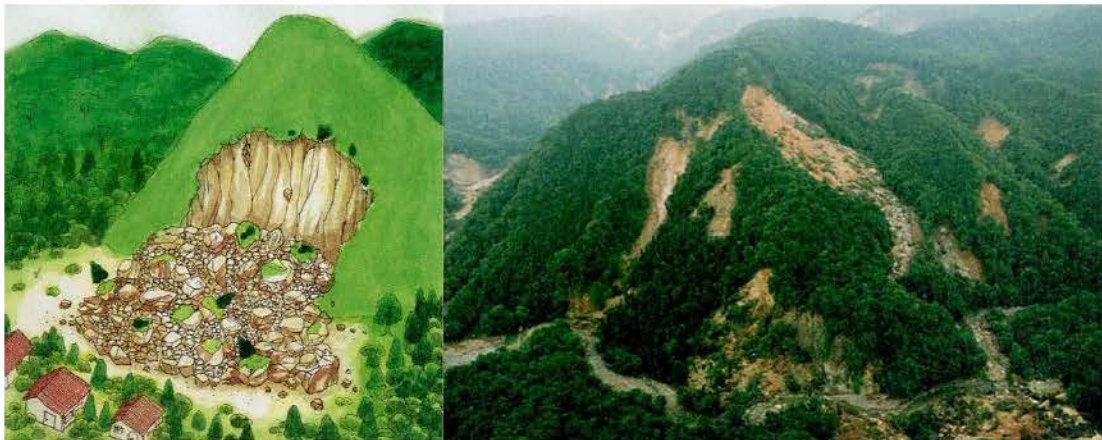
Figure 3.12 Slope failure (Surface landslide) at Ichihasamagawa River Basin (Forestry Agency Japan, 2015)

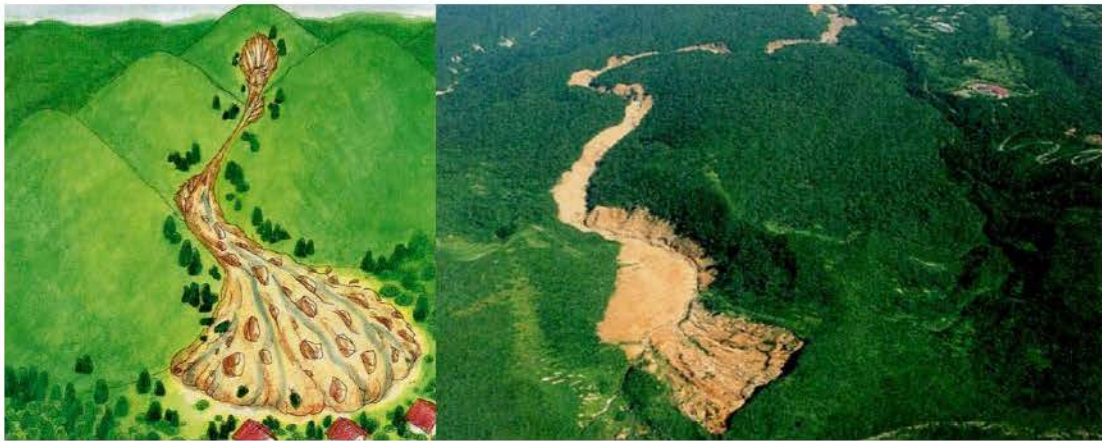
Figure 3.13 Earthflow at Dozousawa (Forestry Agency Japan, 2015)

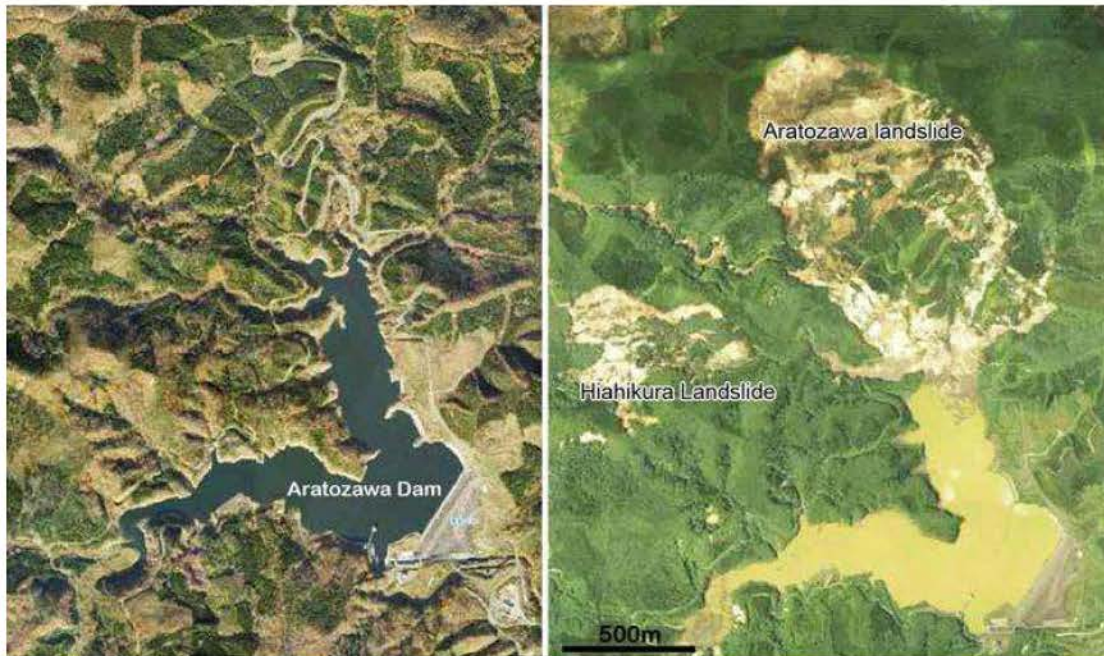
Figure 3.14 Bird's eye view of Aratozawa landslide before and after the landslide event (Miyagi et al., 2011)

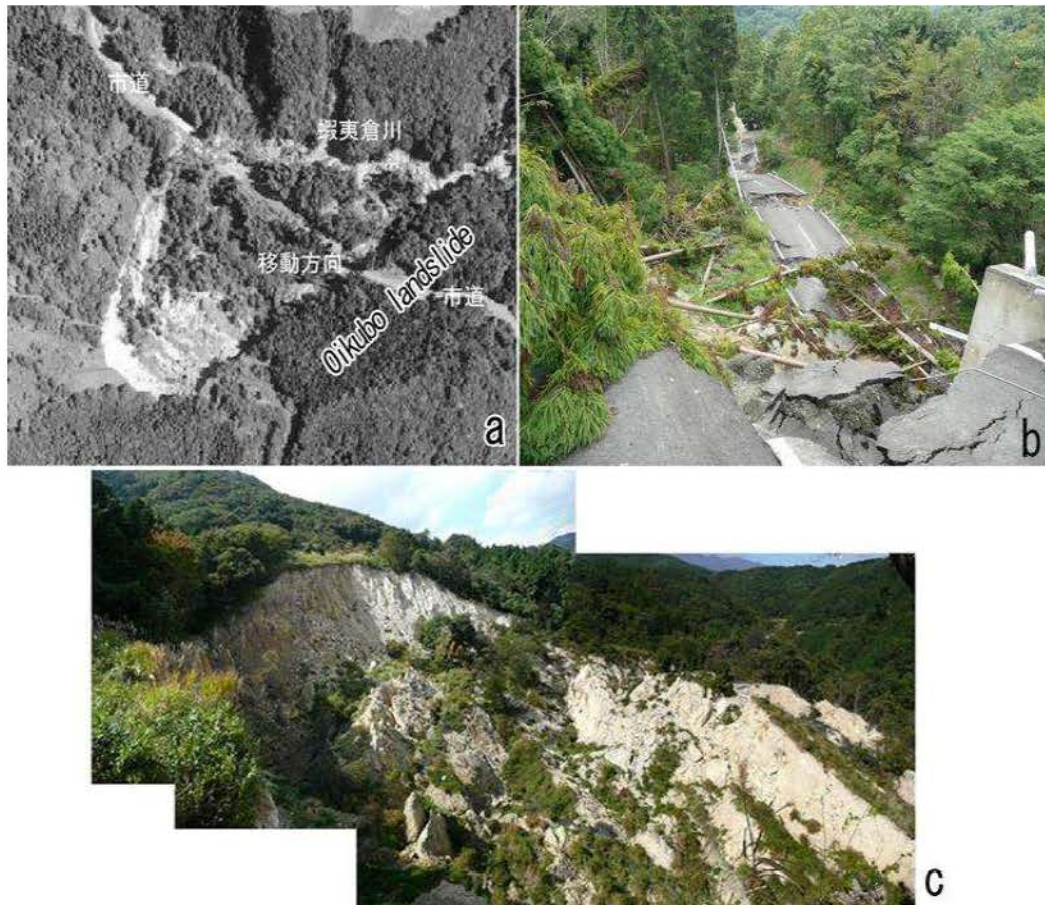
Figure 3.16 Oikubo landslide (a: aerial photograph after the movement; b: prefectural road cut and transformed about 30 m; c: overview of the upper part of landslide (Higaki et al., 2008)

Figure 3.16, Figure 3.17 show the Oikubo landslide, which occurred because of heavy rainfall.

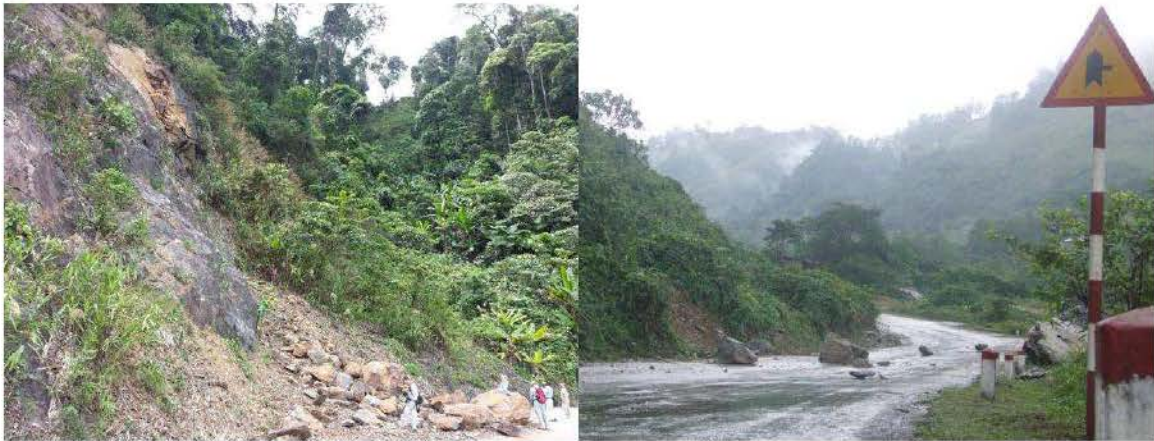
Figure 3.27 Rock fall (photograph by Le)

Rock falls are abrupt movements of masses of geologic materials, such as rocks and boulders, which become detached from steep slopes or cliffs (<http://pubs.usgs.gov>). Separation

occurs along discontinuities such as fractures, joints, and bedding planes. Movement occurs by free-fall, bouncing, and rolling. Rock falls are very rapid to extremely rapid mass movements (from m/min to m/s). Rock falls are influenced strongly by gravity, mechanical weathering, and the presence of interstitial water. In the study area, rock falls were found in Paleozoic zone.

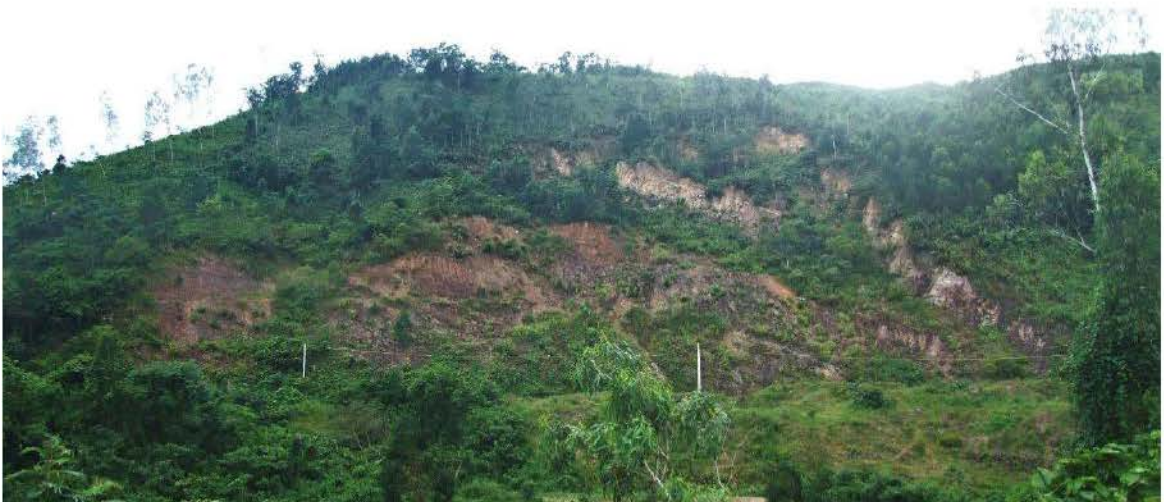
Figure 3.28 Rotational slide (photograph by Le)

Rotational slides occur where the surface of rupture is curved concavely upward and the slide movement is roughly rotational about an axis that is parallel to the ground surface and transverse across the slide. These often involve combined processes of earth movement (rotation of a block of overburden over a broadly concave slip surface, or slump). Rates of movement range from extremely slow (mm/year) to rapid (m/s). In the study area, we usually observe this type in a high weathering zone.

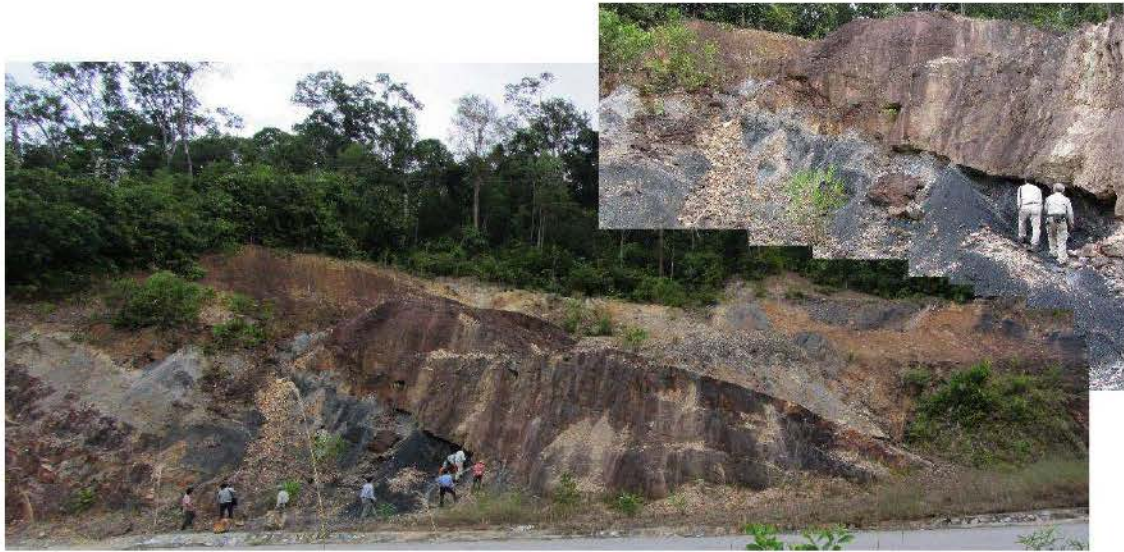
Figure 3.29 Translational slide (photograph by Le)

Translational slides occur where the landslide mass moves along a roughly planar surface with little rotation or backward-tilting. A block slide is a translational slide in which the moving mass consists of a single unit or a few closely related units that move downslope as a

coherent mass. Movement rates range from rapid (m/min) to extremely rapid (m/s) and are usually initiated below the surface. Most slides of this type occur in the Mesozoic zone.

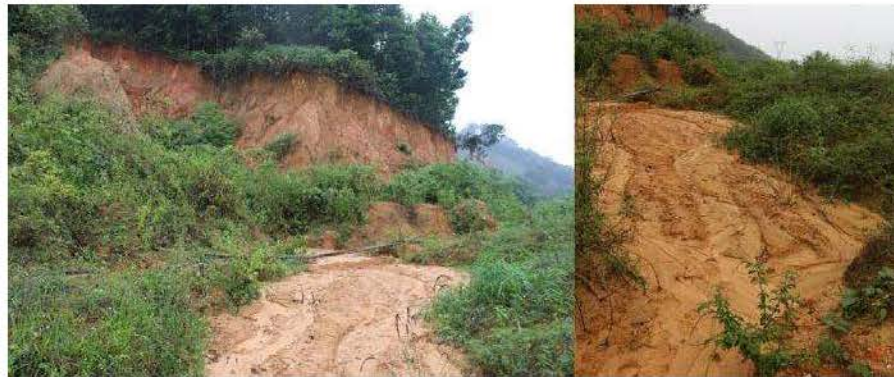
Figure 3.30 Debris flow (photograph by Le)

A debris flow is a form of rapid mass movement in which a combination of loose soil, rock, organic matter, air, and water mobilize as a slurry that flows downslope. Debris flows include <50% fines. Debris flows are commonly caused by intense surface-water flow, because of heavy precipitation, that erodes and mobilizes loose soil or rock on steep slopes. Debris flows also commonly mobilize from other types of landslides that occur on steep slopes, are nearly saturated, and consist of a large proportion of silt-sized and sand-sized material. Debris-flow source areas are often associated with steep gullies, and debris-flow deposits are usually indicated by the presence of debris fans at the mouths of gullies. Fires that denude slopes of vegetation intensify the susceptibility of slopes to debris flows.

Debris flows commonly follow existing drainage ways or linear slope depressions created by past landslide activity, although not necessarily. Debris flows tend to increase in volume downstream. Rates of movement range from rapid (m/min) to extremely rapid (m/s).

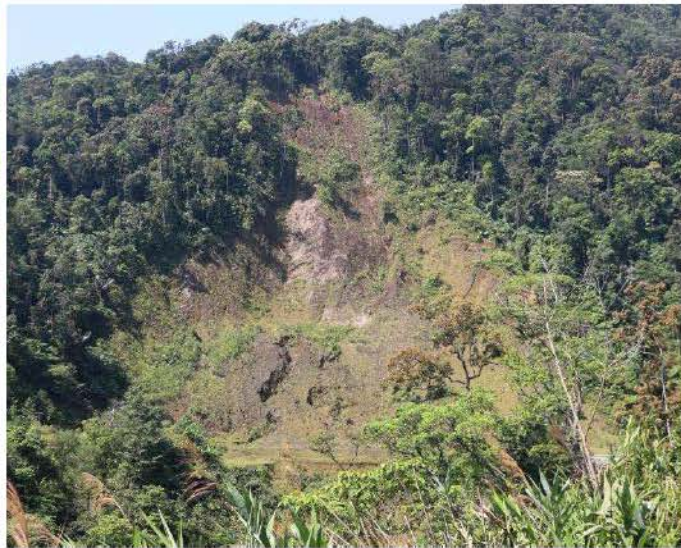
Figure 3.32 Wedge type (photograph by Le)

Wedge type slides are defined as sliding of a mass of rock on a planar rupture surface, or a wedge of two planes with downslope-oriented intersection. The rupture surface might be stepped. No internal deformation occurs. The slide head might be separate from stable rock along a deep, vertical tension crack. Usually, it occurs very rapidly. Figure 2.11 is typical of this type. Figure 3.32 is large scale wedge type, which combines multiple small wedge types.

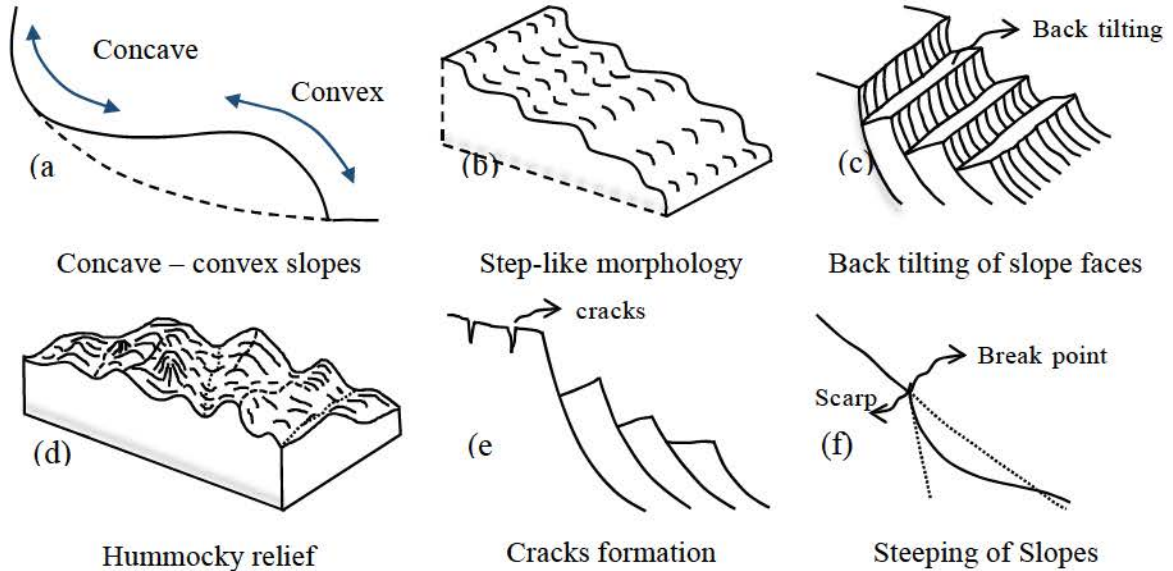
Figure 4.3 Morphological characteristics of landslides (modified from referenced data)

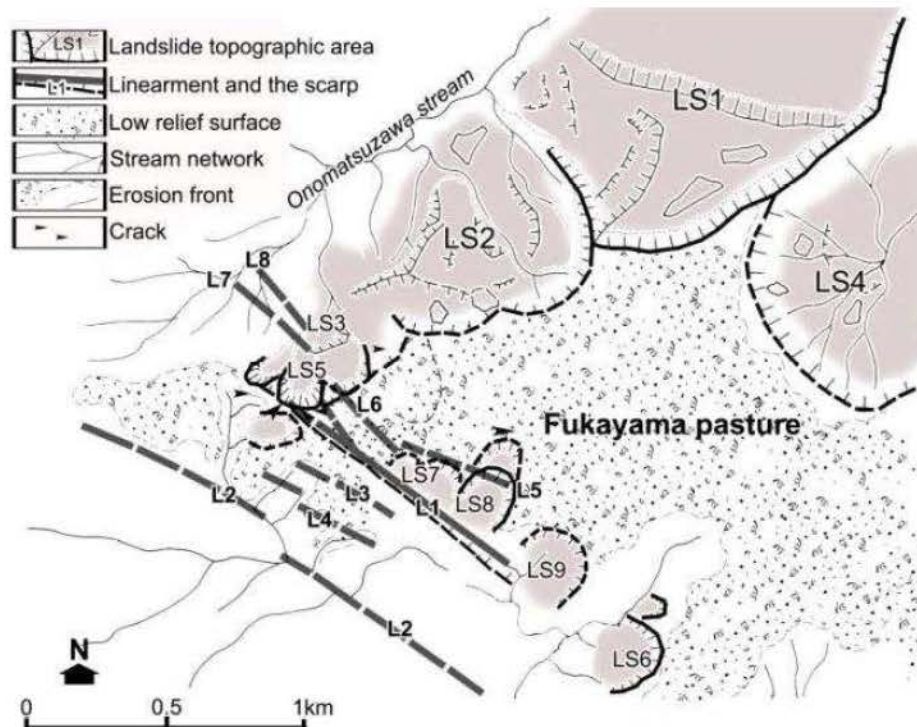
Figure 4.4 Distribution of landslide topography, lineament, and cracks at the area of Fukayamadake plateau, Mt. Kurikoma foot slope, Miyagi Prefecture, northeastern Japan (Le and Miyagi, 2015c)

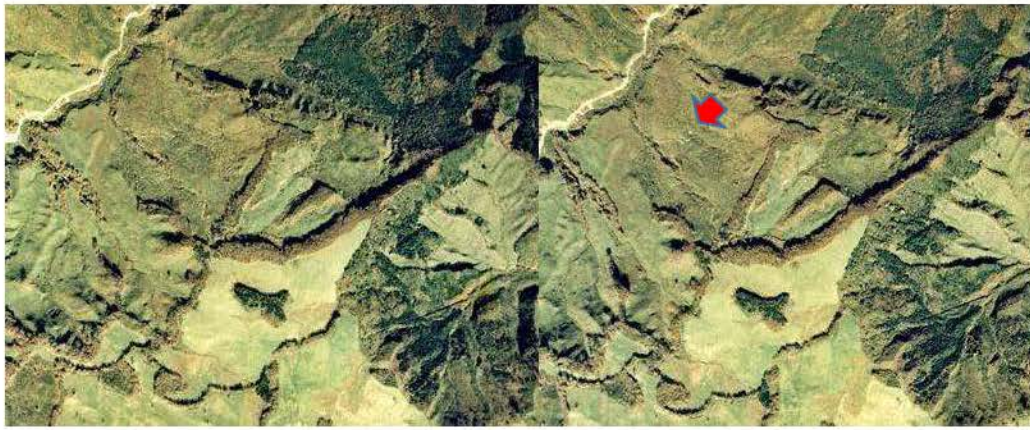
Figure 4.5 Stereo aerial photograph pair (CTO-76-13-17B-23 & 24) showing landslide LS1 in Figure 4.4

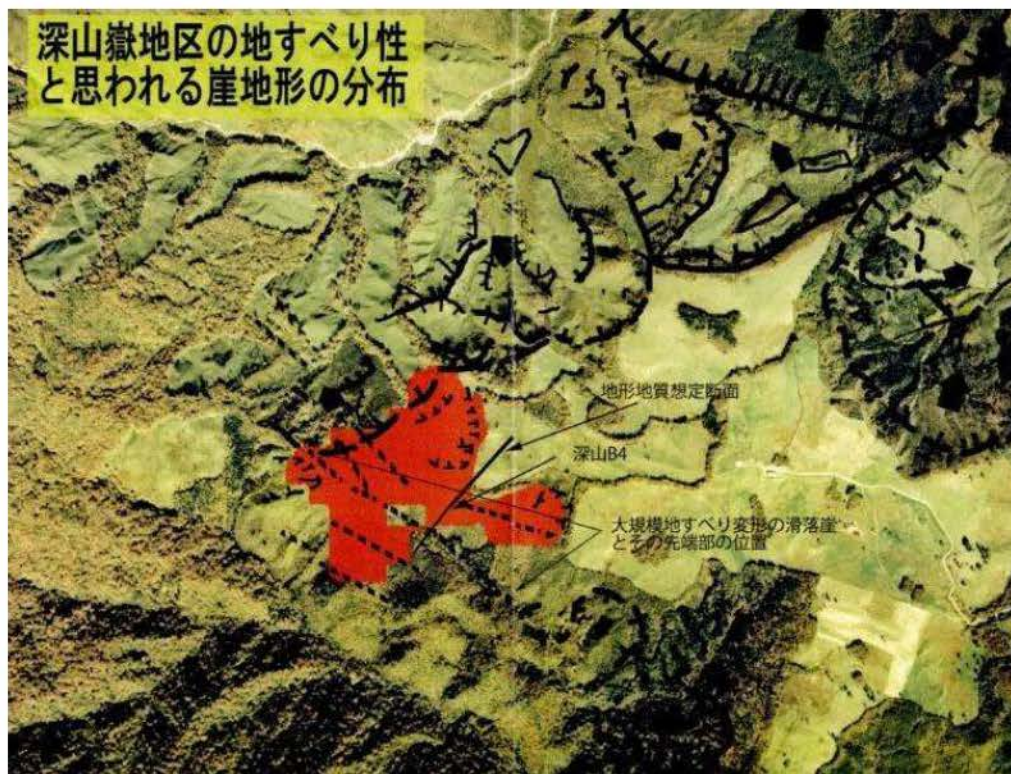
Figure 4.6 Aerial photograph of the study area presented in Figure 4.4

Many characteristics presumed to have been formed by landslides were observed around the Fukayama pastureland, which were recognized as landslide topographic areas. Many lineaments were also found on the south slope of the pastureland. Although all local areas show intrusion by arborescent dissection valleys, the relative age of topographic areas was determined by the degree of erosion of landslides and lineament topographic areas by a dissection valley. The interpretation results are presented in Figure 4.4. Its outline is presented below.
