**TOHOKU GAKUIN UNIVERSITY
GRADUATE SCHOOL OF HUMAN INFORMATICS**

**LARGE SCALE LANDSLIDE RISK EVALUATION BY
AERIAL PHOTOGRAPH INTERPRETATION AND
INTEGRATED AHP APPROACH FOR HUMID TROPICAL REGION
BASED ON JAPAN AND VIET NAM FIELD SURVEYS**

DISSERTATION

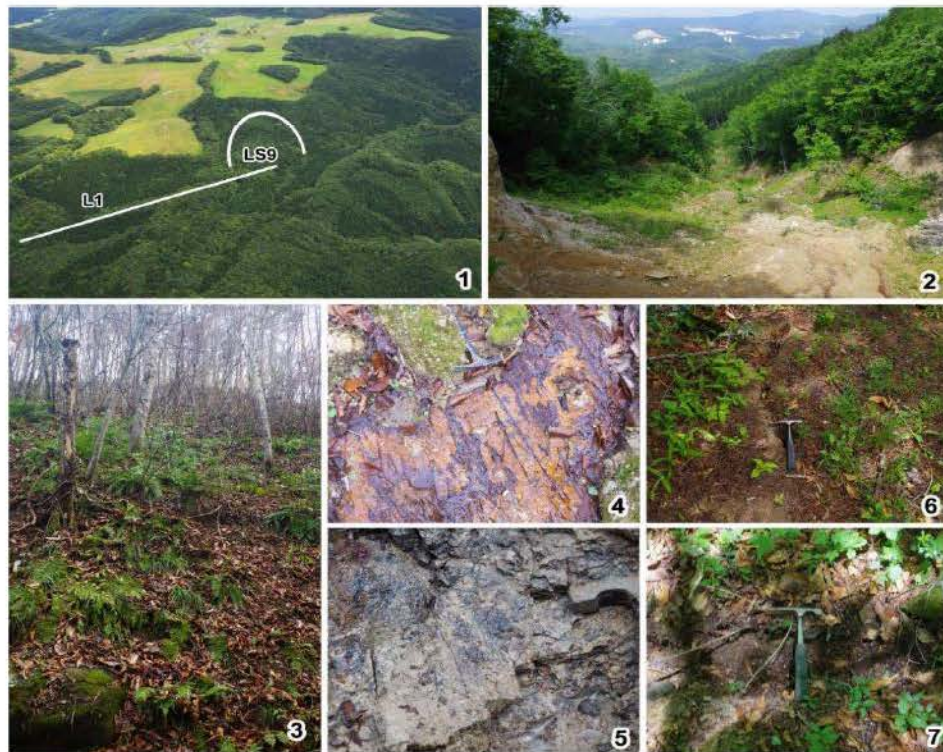
Figure 4.7 Field evidence of the landslide related features at Fukayamadake area (Le and Miyagi, 2015c):

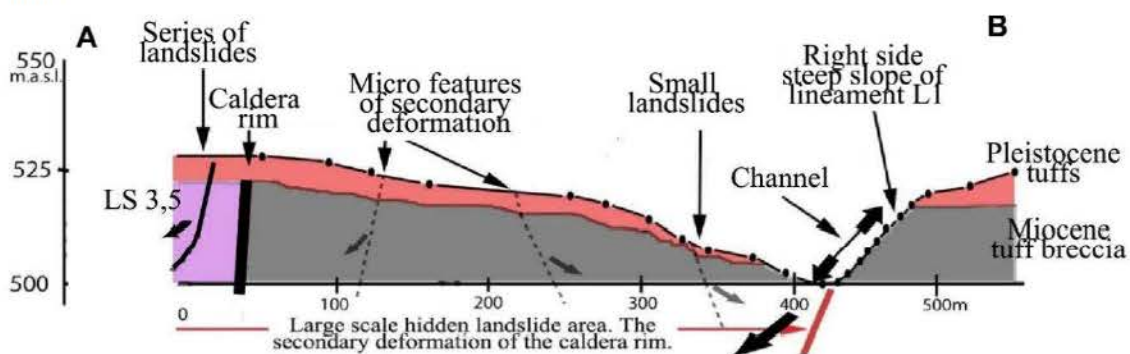
Figure 4.8 Topographical and geological cross section passing from L1 through LS 3,5 (Le and Miyagi, 2015c)

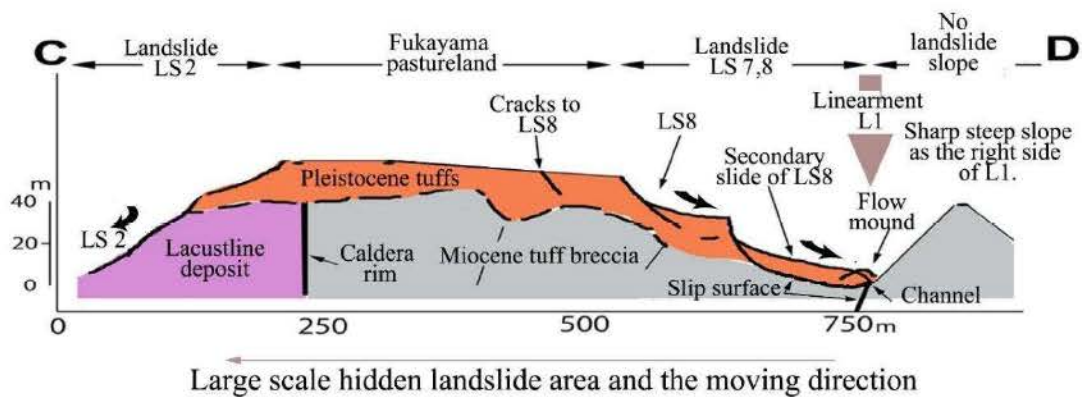
Figure 4.9 Cross profile at LS 7,8 areas

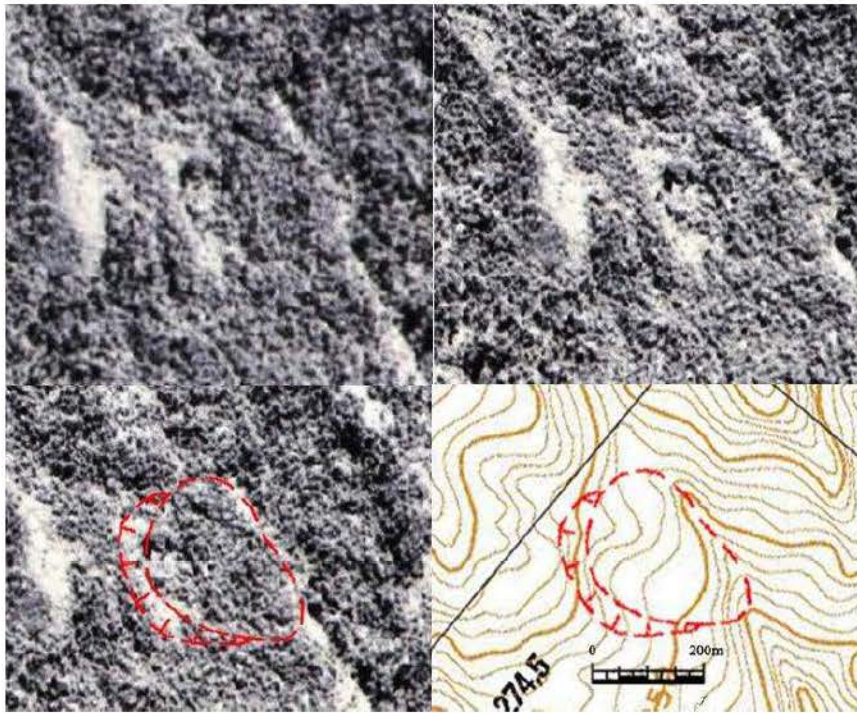
Figure 4.11 Stereo pair aerial photograph (D2-99-06-415 & 416) showing a typical rotational slide (Le et al., 2016): the upper panel shows stereoscopic image of landslide; the lower panel is a sketch of landslide on photographs and topographic maps

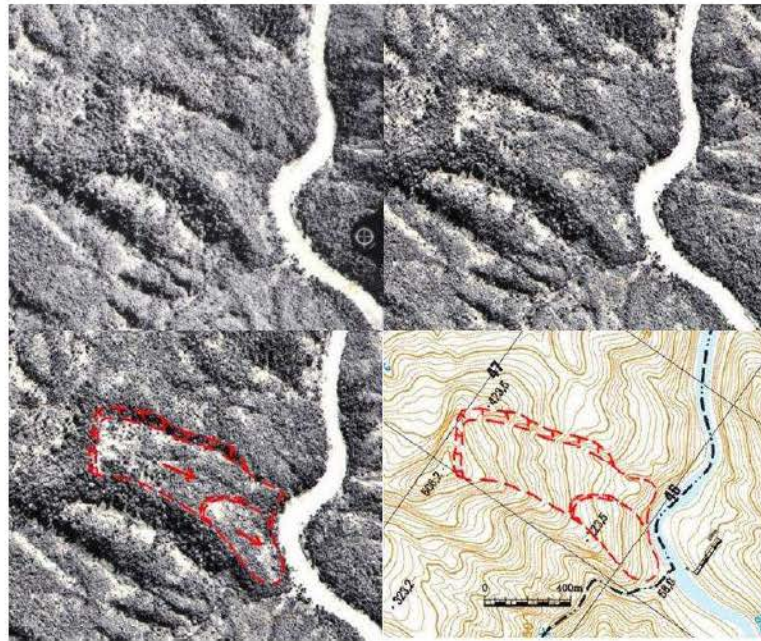
Figure 4.12 Stereo aerial photograph pair (D2-99-06-415 & 416) showing a typical translational slide (Le et al., 2016): the upper panel shows stereoscopic image of landslide; the lower panel is sketch of landslide on photographs and topographic maps

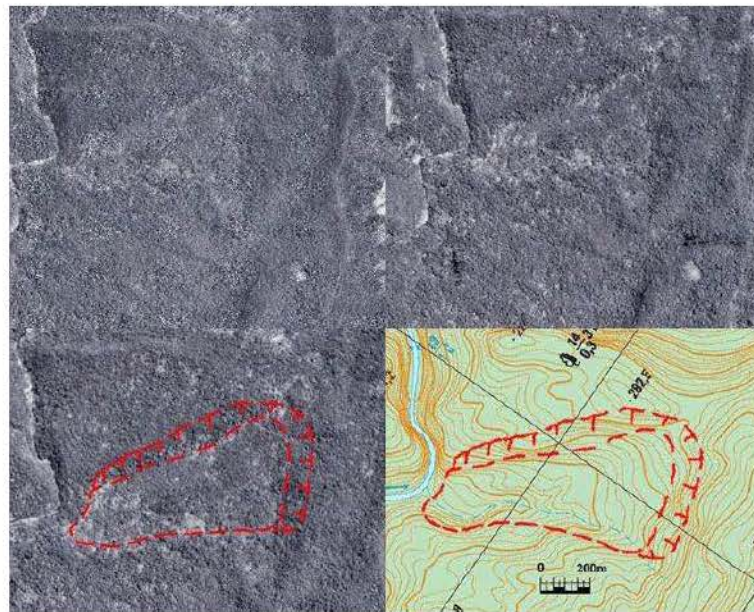
Figure 4.13 Stereo pair aerial photograph (D2-99-04-226 & 227) show typical of compound slide (Le et al., 2016): the upper panel shows stereoscopic image of landslide; the lower panel is a sketch of a landslide on a photograph and a topographical map

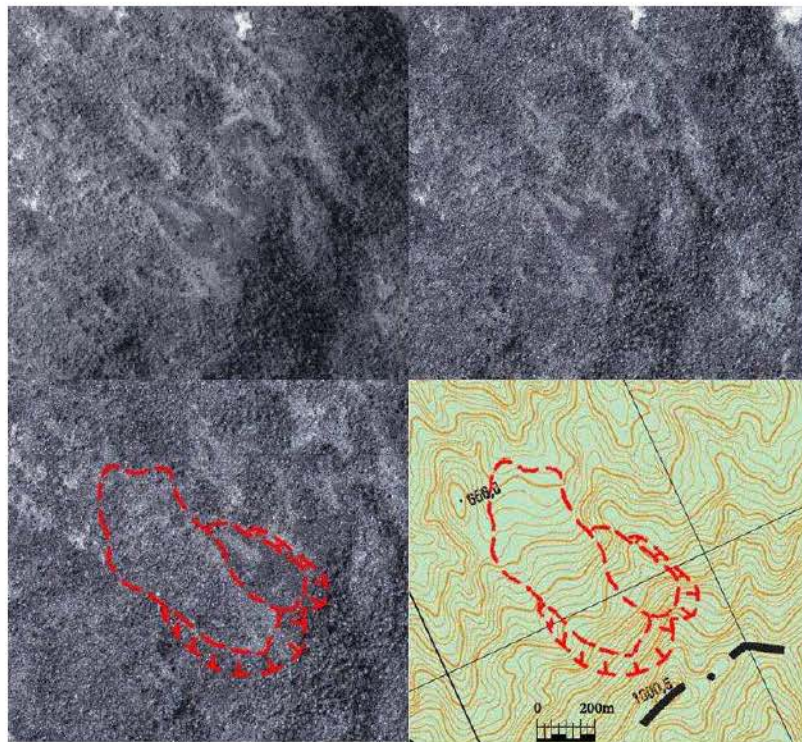
*Figure 4.14 Stereo pair aerial photograph (D2-99-03-244 & 245) show typical of debris slide (Le *et al.*, 2016):*

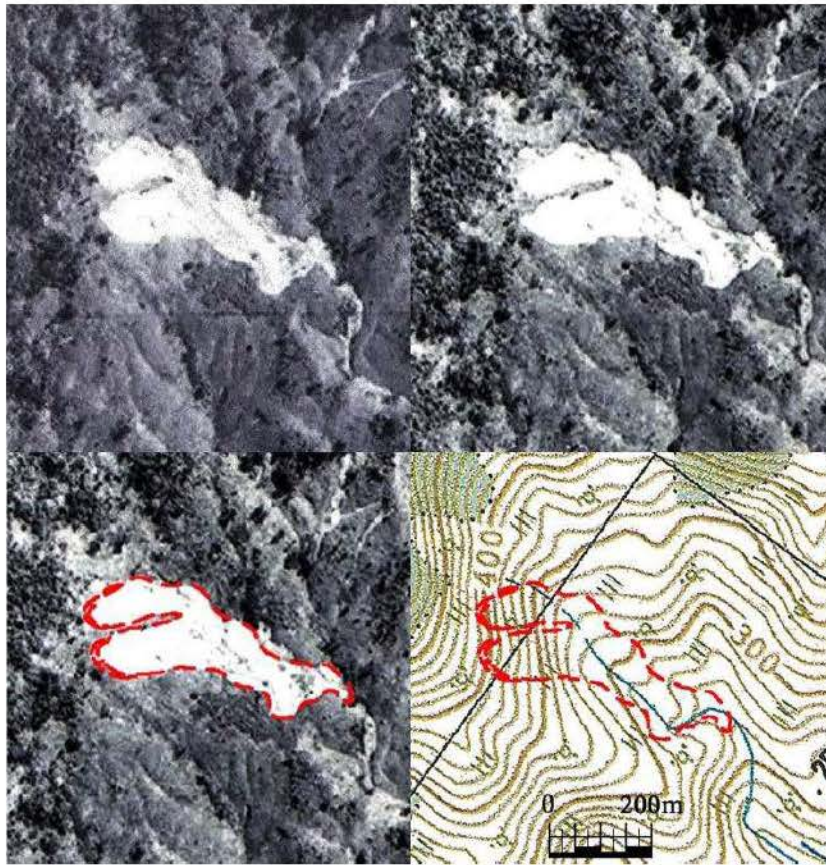
Figure 4.15 Stereo pair aerial photograph (D2-99-06-127 & 128) show typical of debris flow (Le et al., 2016):
the upper panel is a stereoscopic image of a landslide; the lower panel is sketch of a landslide on photograph and topographic map

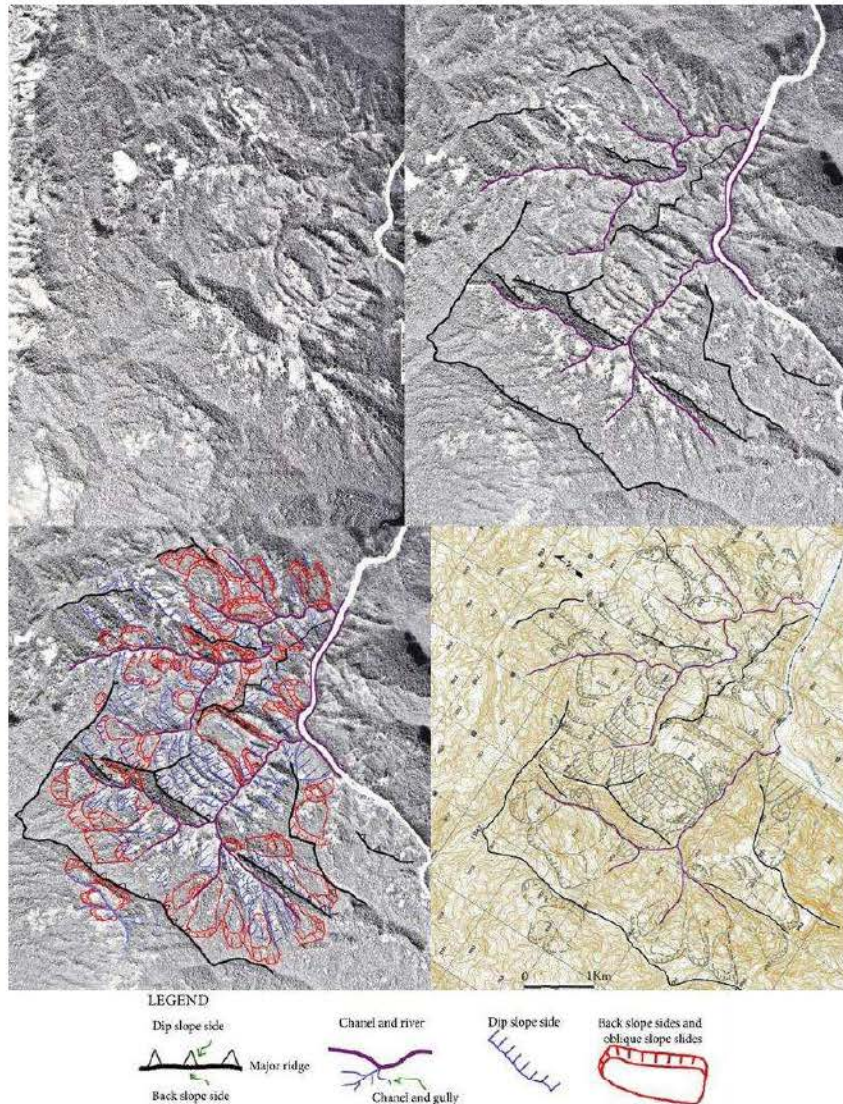
*Figure 4.17 Stereo pair aerial photograph (D2-99-06-415 & 416) show main joint plane and bedding plane having tendency to parallel to or dipping with slope (Le *et al.*, 2014b): the upper panel shows stereoscopic image of landslide; the lower panel shows a sketch of landslide and micro-landform features on photograph and topographic map*

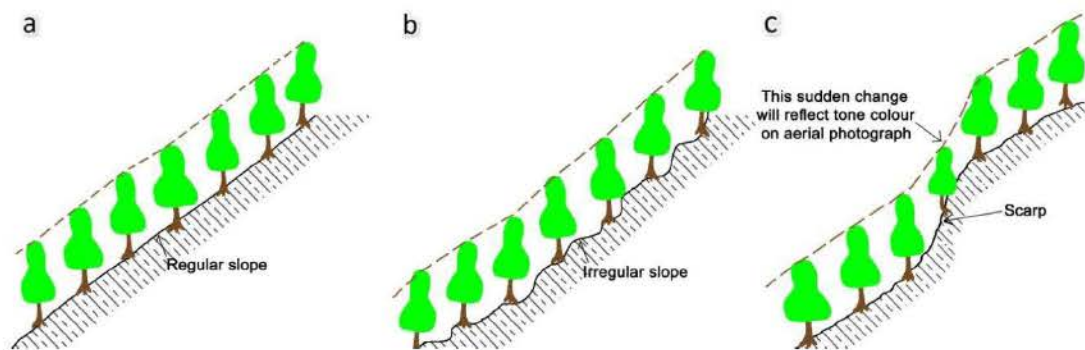
Figure 4.22 Schematic views of regular/irregular slopes (Le et al., 2016): Identifying irregular slope is extremely difficult because of high vegetation cover if there is sudden change of slope such as a scarp. It is shown as tone color that can be easily identified on aerial photographs

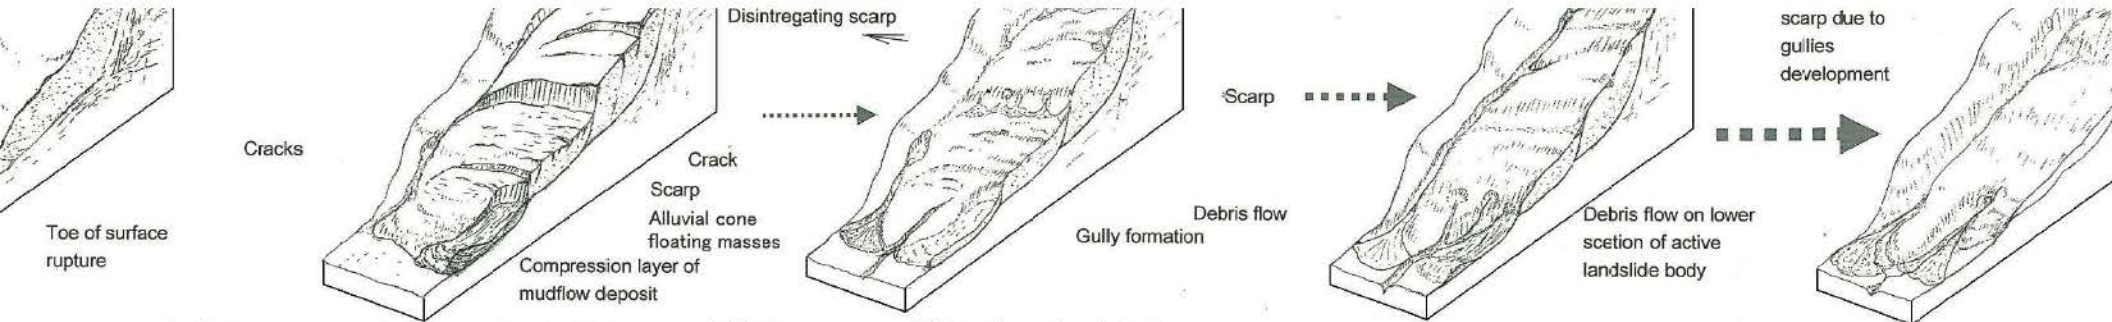
In this stage upper mass is sliding as dissecting blocks, cracks are in advance stage on crown and body. Scarps have sharply developed in the upper section, debris flow is accumulating as compressing layers at lower section, surface rupture is clearly defined, all these factors are fresh and in active stage.

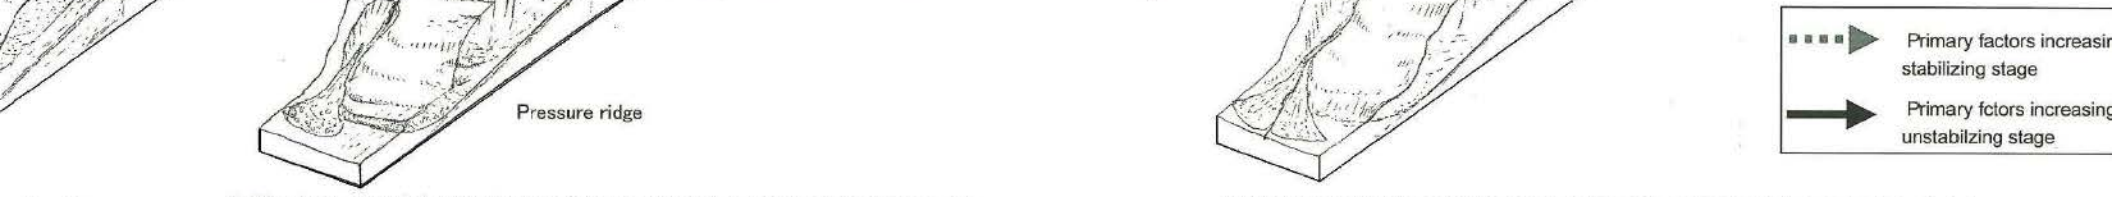
II - 2: Last stage of landslide

In this stage several clear cracks appeared. Several transverse and minor scarps have dissected the body into blocks and small debris slides and pressure ridge have developed at the lower section due to load pressure of upper moving blocks, this is known as active stage of translational type of block slide,

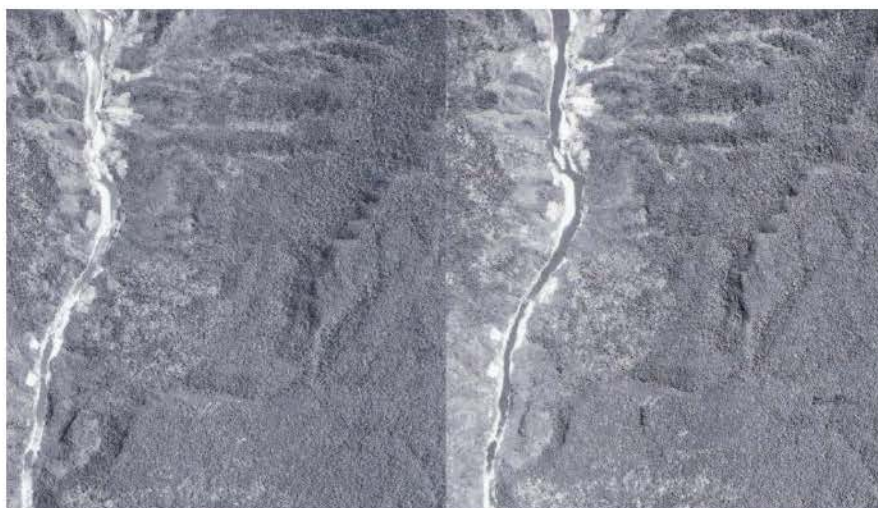
Figure 5.3 Stereo pair of aerial photographs (D2-99-04-228 & 229) showing landslide No. 163

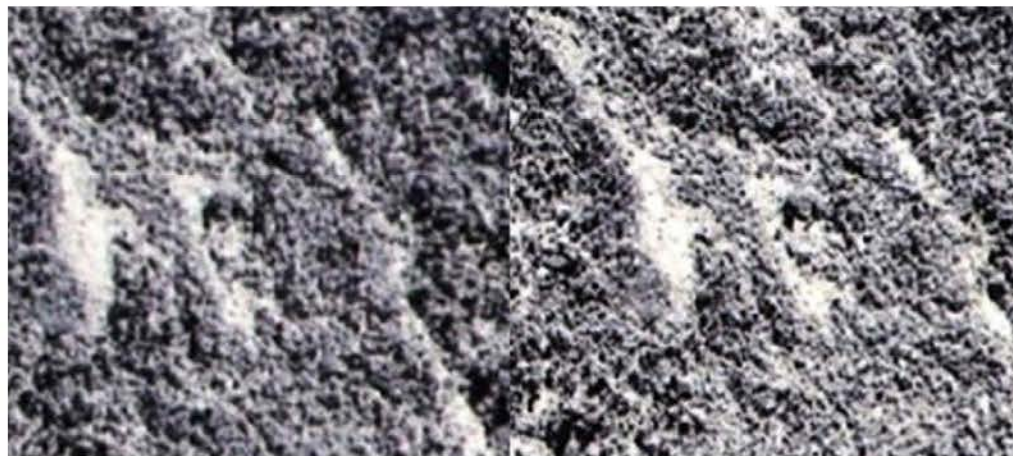
Figure 5.4 shows a stereo pair aerial photograph of landslide No. 102. This is a typical rotational slide that is 0.295 km long and 0.301 km. The block is very clear, with hits and blocks of the stream. A depression is apparent behind the block, with ponding in niches of the back-tilting area. The boundary is extremely clear. The total score is 70.2. This landslide is classified as having high probability of landslide occurrence.

Figure 5.4 Stereo pair of aerial photographs (D2-99-06-415 & 416) showing landslide No. 102 (Le et al., 2016)

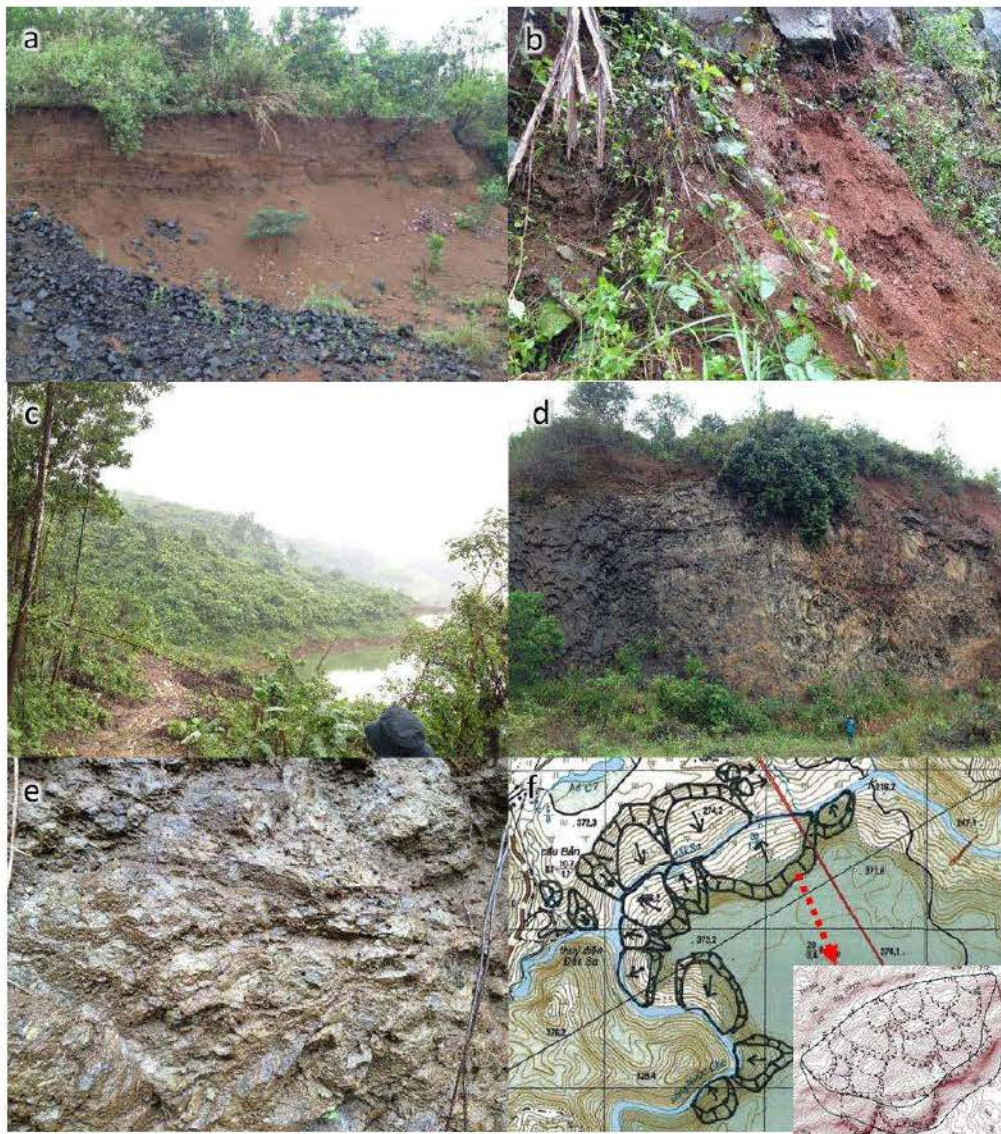
Figure 5.5 Typical example of landslide related to geology in the Quaternary zone (Le et al., 2015b):

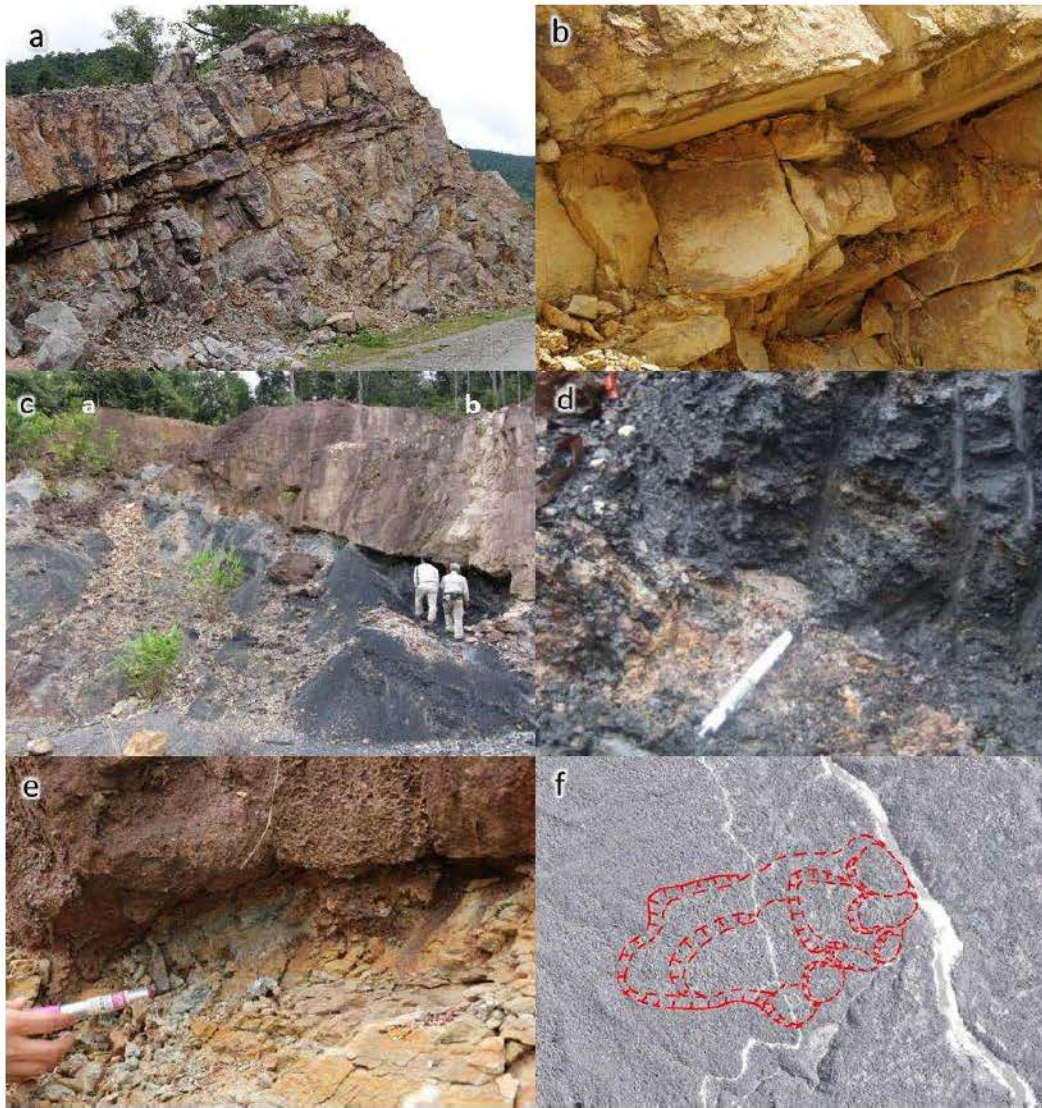
Figure 5.6 Typical example of landslide with emphasis on geology in the Mesozoic (Le et al., 2015b)
 a: bedding plane parallel to slope; b: fractures of sedimentary rock; c: lens of coal layer; d, e: slip surface at weak layer; f: aerial photograph of landslide

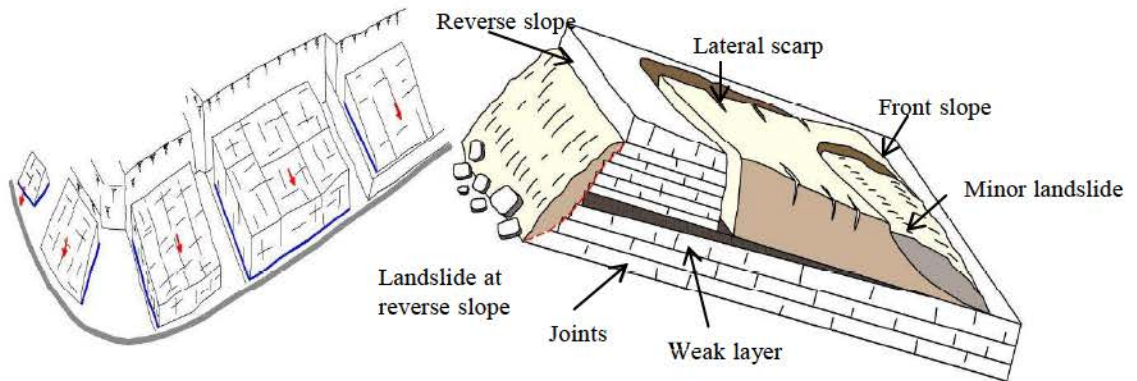
Figure 5.7 Translational rocks slide at Mesozoic zone (Le et et al., 2016)

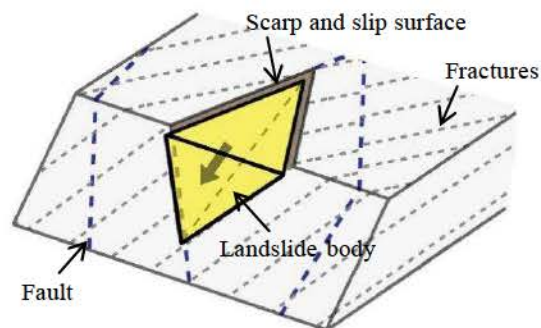
Figure 5.8 Schematic diagram of joints and fractures cause wedge slide type (Le *et al.*, 2016)

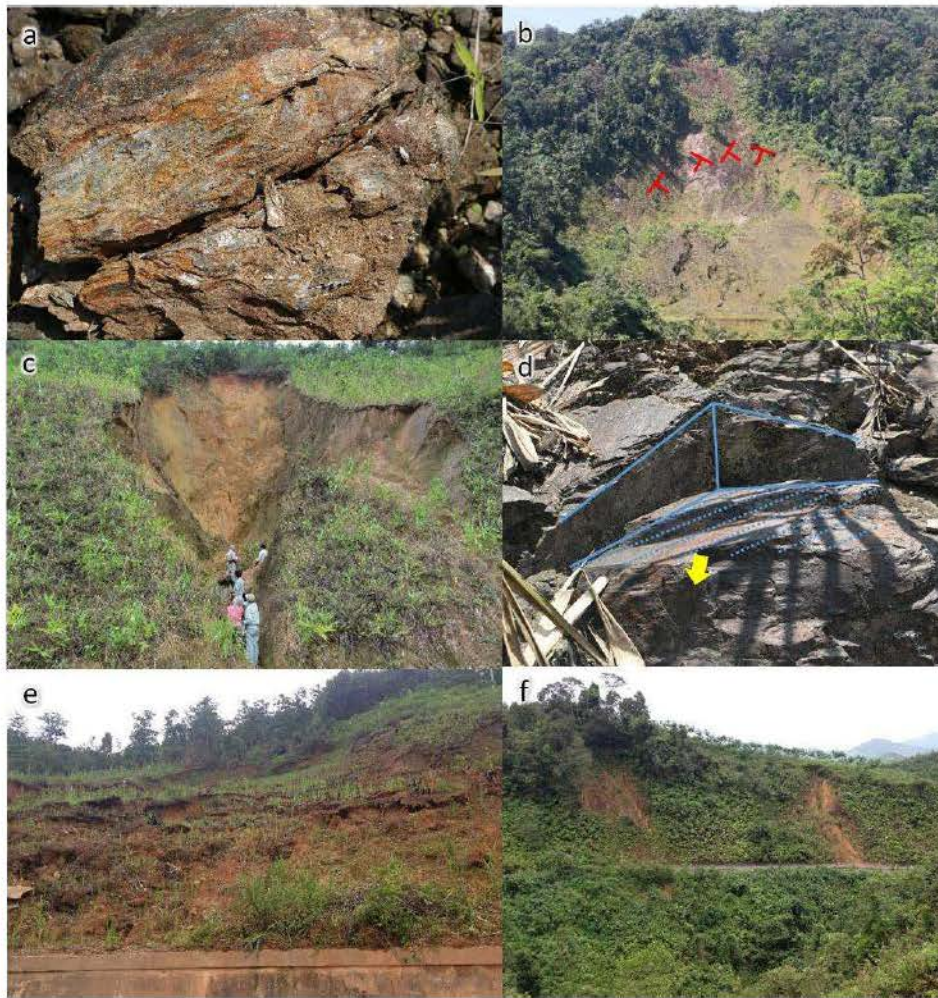
*Figure 5.9 Typical example of landslide emphasizing geology in Paleozoic (Le et al., 2015b):
a: weathered schist stone; b, c, d: wedge type; e: slump type; f: debris slide*

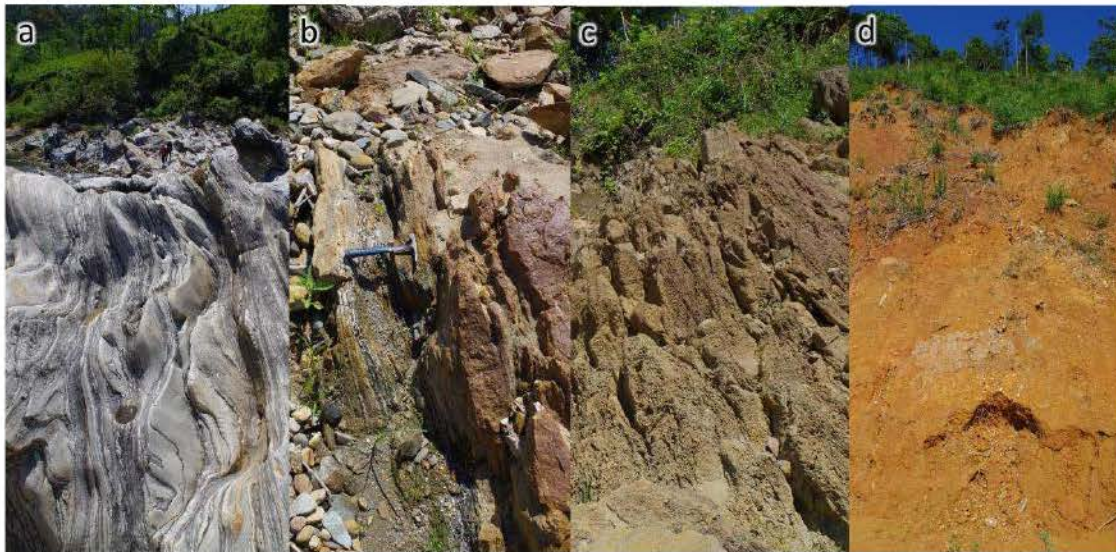
Figure 5.10 History of weathering at Precambrian (Le *et al.*, 2016):
a: gneiss, b: medium weathering gneiss, c: weathered gneiss; d: highly weathered granite

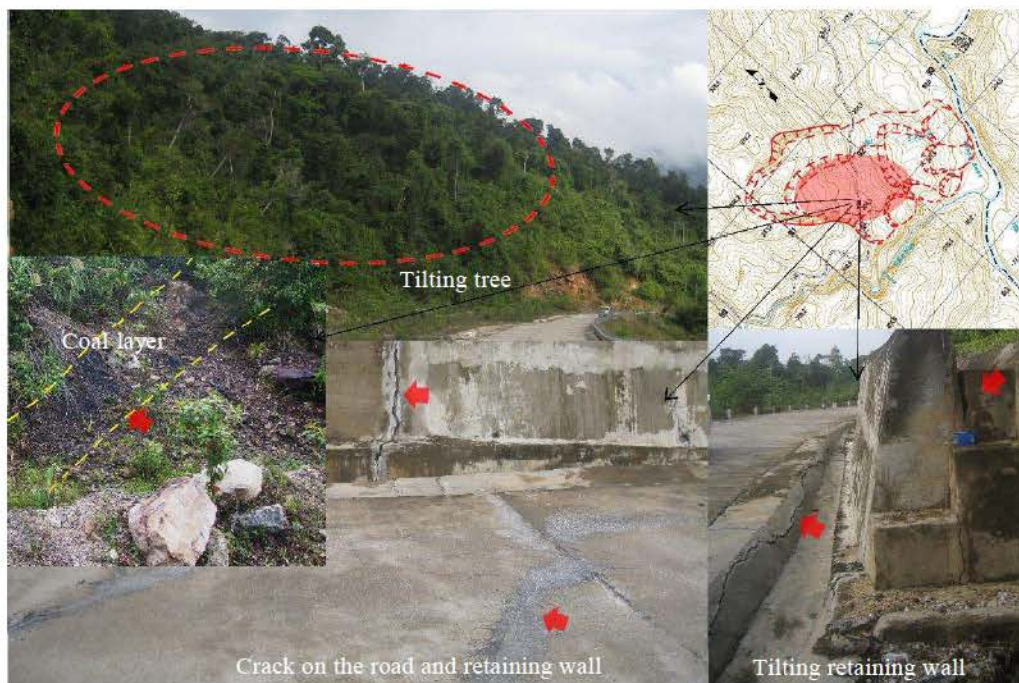
Figure 5.12 Some evidence of landslide action was observed at a part of landslide No. 18 (Le, 2015a)

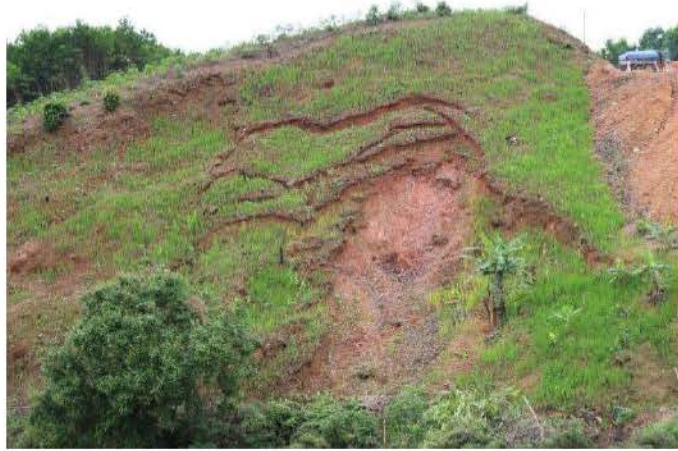
Figure 5.13 Debris slide at highly weathered Paleozoic river valley side slope (Le et al., 2016)
